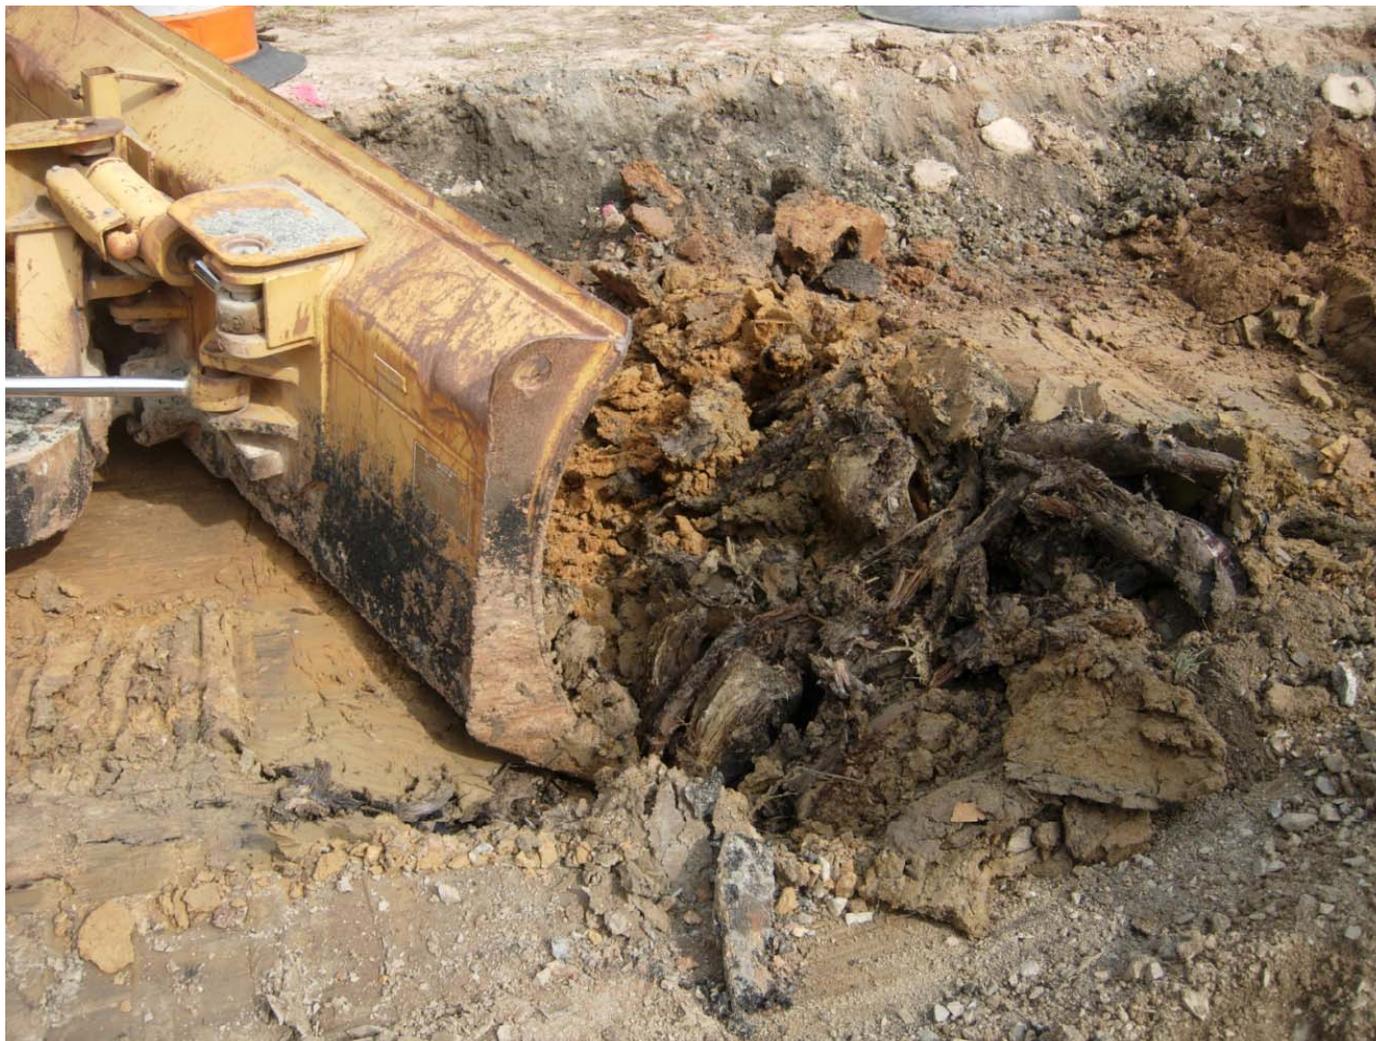
Trees buried beneath the road!

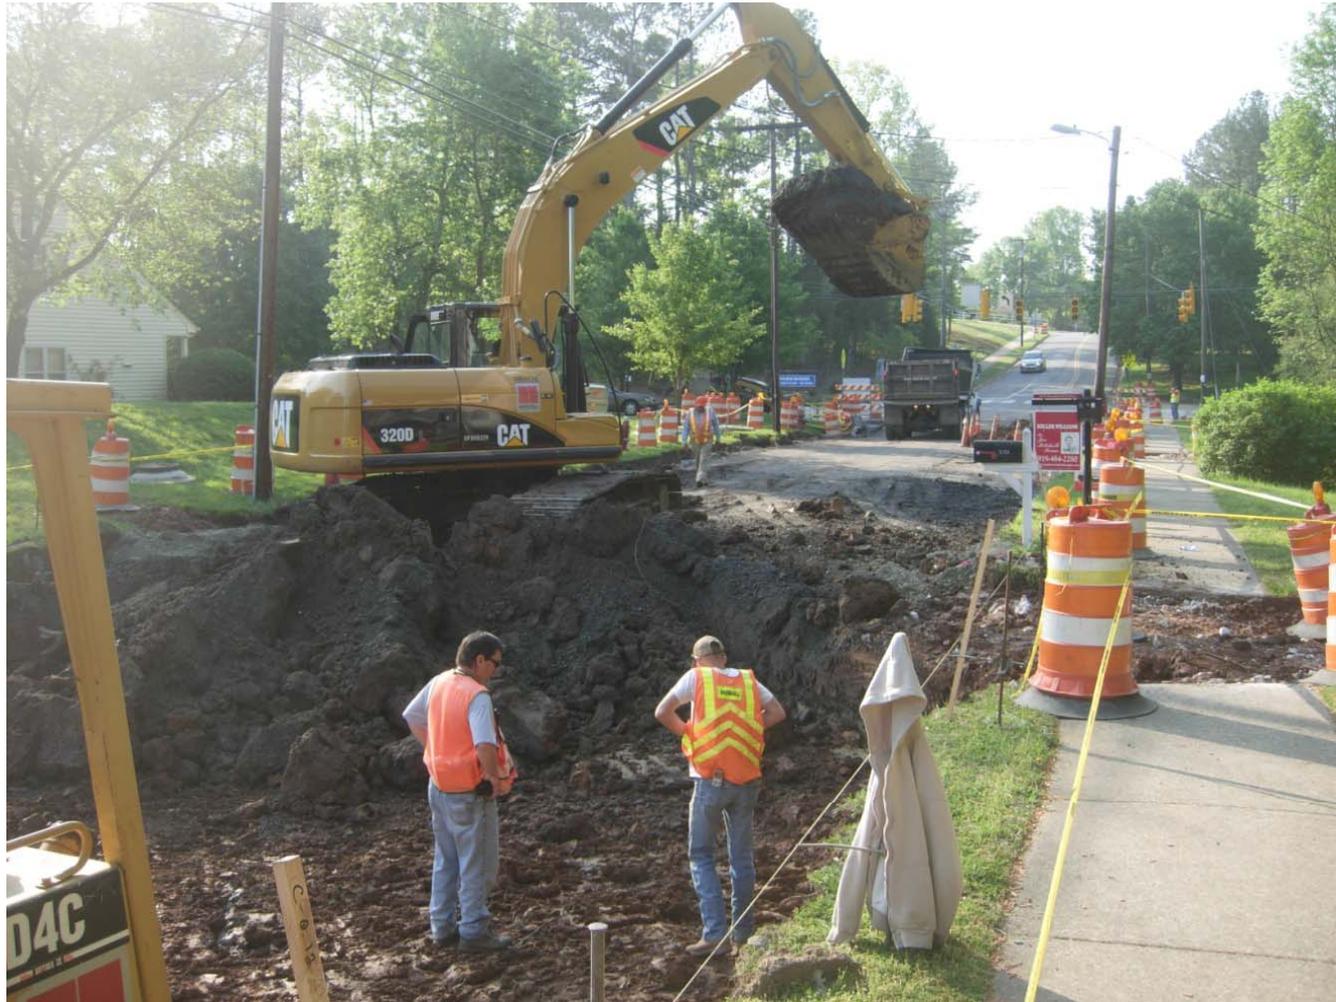
Extremely Poor Structural Soil Under Road

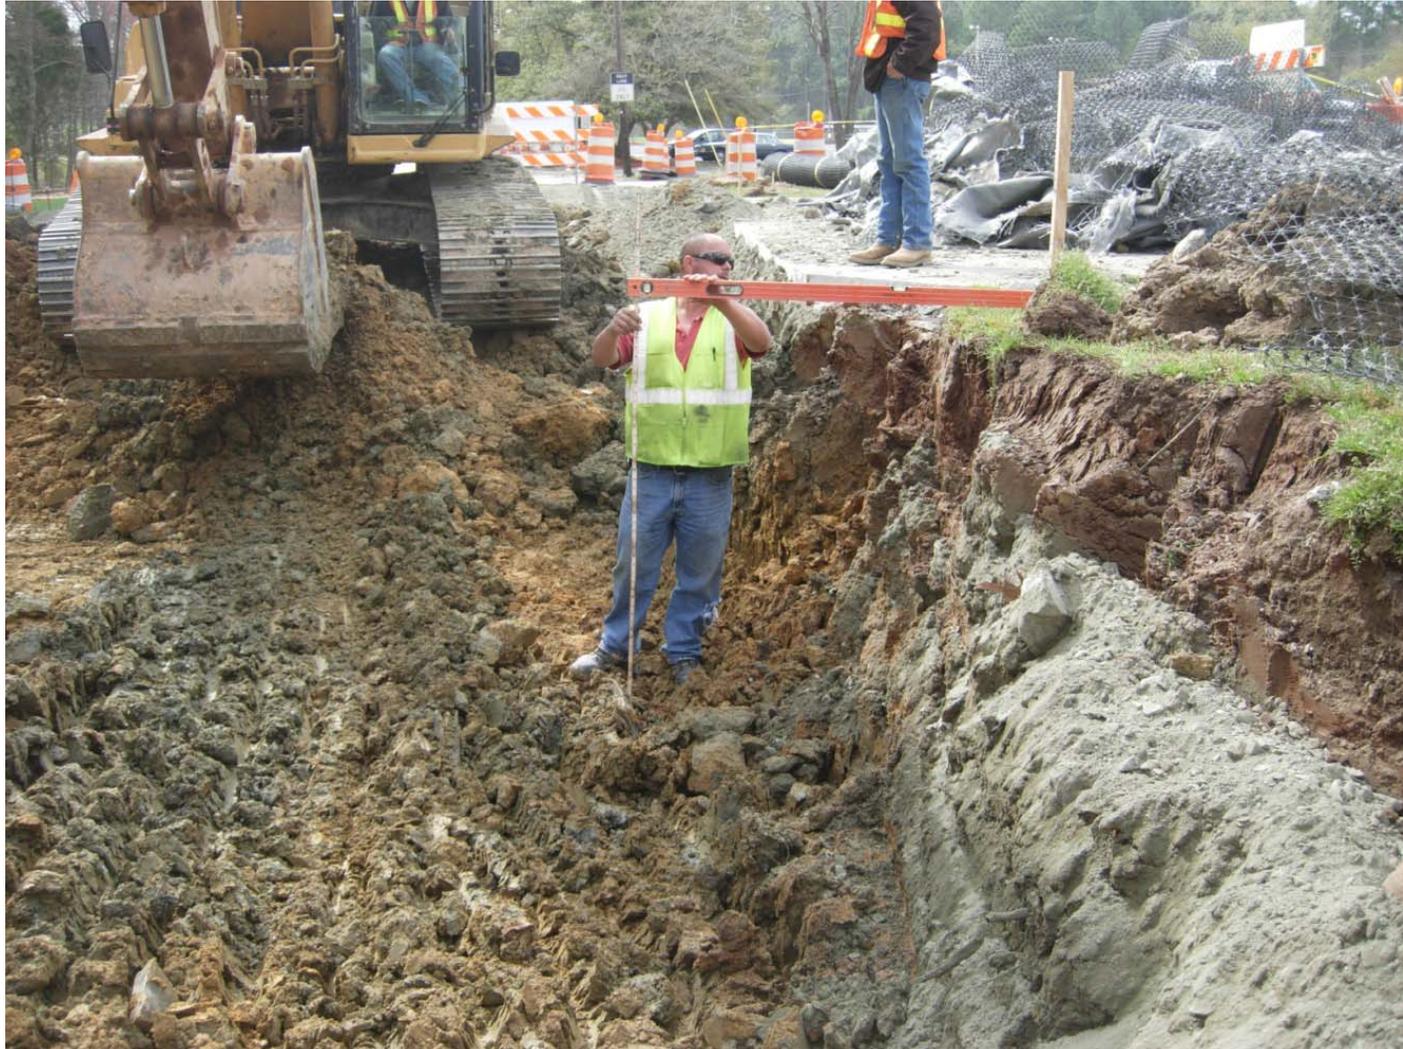
A Five Foot Deep Cut Under Revere Road
