Building Assessment for Duke Park Bathhouse

Durham, North Carolina

December 15, 2009

Final Report

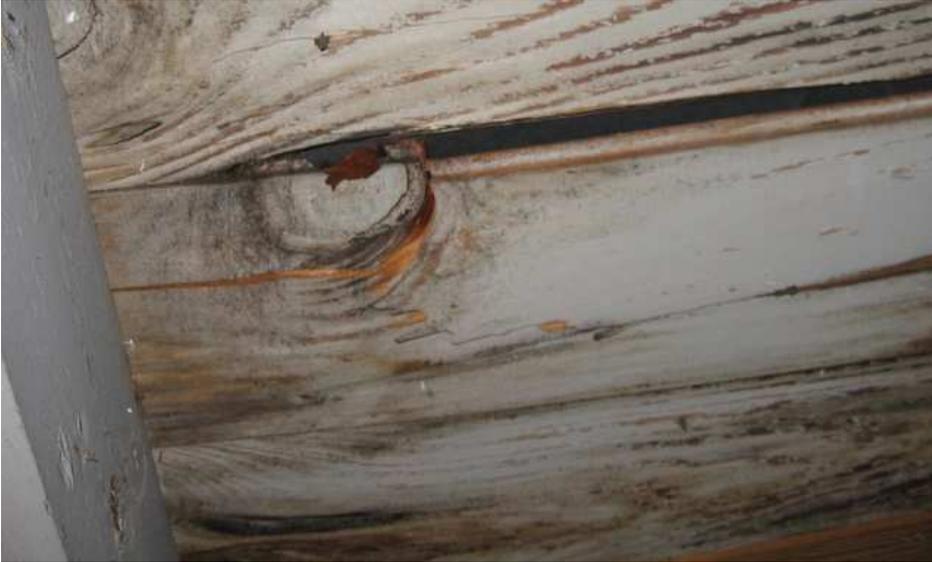
Note that the design and the construction of the roof framing is not in accordance with the modern building code for wood construction. Some areas of particular concern are the use of slender, unbraced compression members, the location and method of nailed splices in rafters, and nailed connections at rafter ends (Fig 1-4).

Figure 1-1 – Separation of Sheathing Boards

Recommendation: The roof framing system should be reviewed in detail and be repaired and strengthened to meet the requirements of the building code.

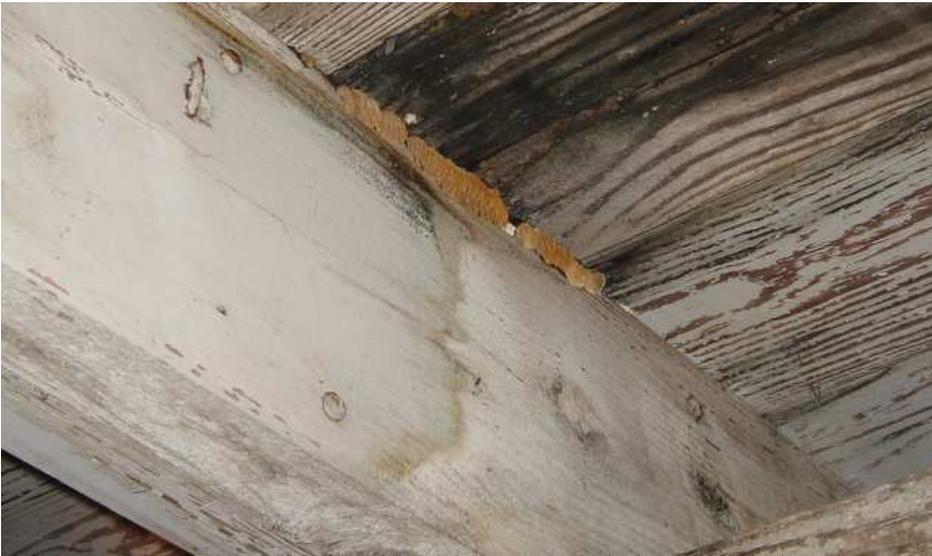
1. Roof Framing and Decking – The roof structure is comprised of 1" thick sheathing boards supported by trussed framing. Some of the sheathing has been replaced in the past and a number of rafters have been sistered due to water damage. Overall, much of the wood is sound, although isolated cases of damage are present in sheathing and a few rafters (Fig 1-1, 1-2). This material should be replaced on a case-by-case basis and new rafters sistered to old. There is one instance where the roof framing has separated from the column support below (Fig. 1-3); this should be addressed with the column replacement discussed later.

Figure 1-2 – Damaged Rafter and Sheathing

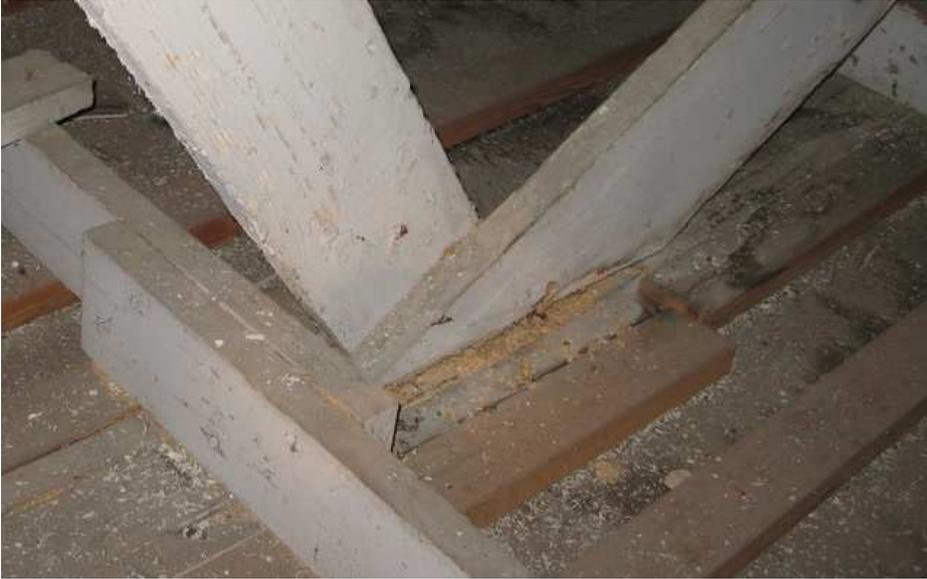
Figure 1-3 – Separation of Framing from Column Support

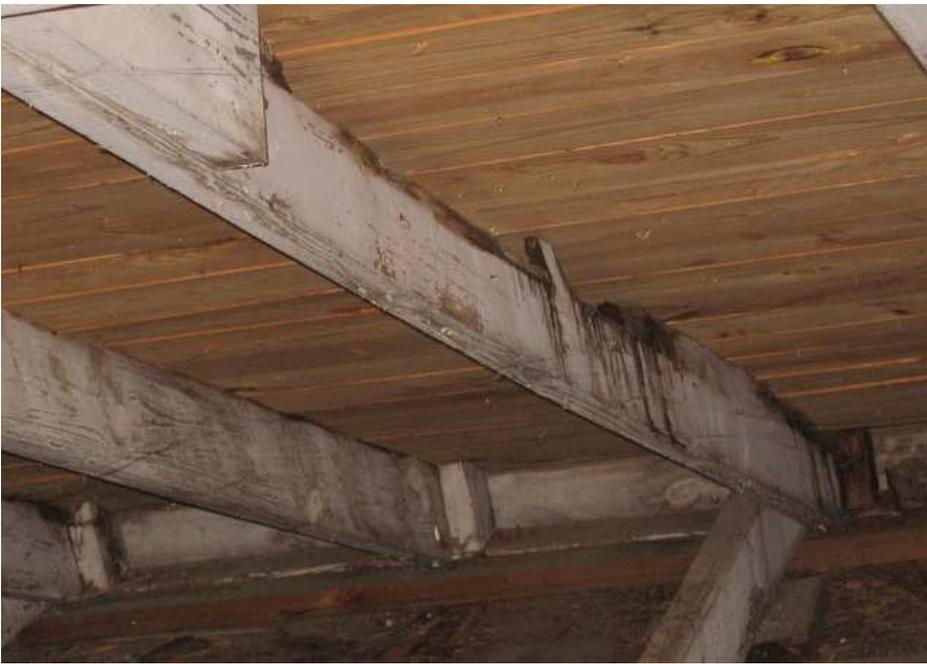
Figure 1-4 – Rafter Damage and Nailed End Connection

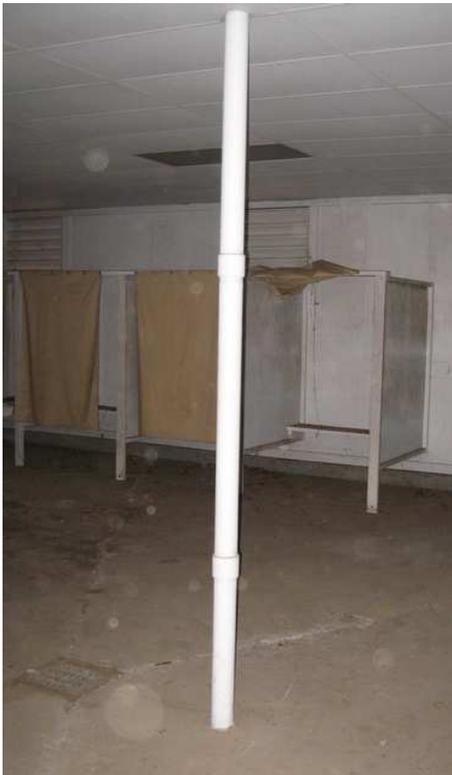
2. Columns and Exterior Walls – A series of columns support a continuous wood beam that bisects the roof frame. The middle bays are supported by columns that consist of 4' lengths of 3 ½" OD cast iron pipe with threaded couplings (Fig. 2-1). This type of splice is not a sound method of joining a compression member and should be replaced. Also, the cap plates supporting the 6" beam are undersized by modern standards (Fig. 2-2). End columns are 6x6 wood members; both of these columns are failing due to extensive rot (Fig 2-3) and should be replaced immediately.

Figure 2-1 – Interior Column with Threaded Couplings

Recommendation: The columns should be replaced with new columns. The two wood columns should be replaced immediately. The wall siding should be removed to allow for visual inspection of the wood wall framing system.

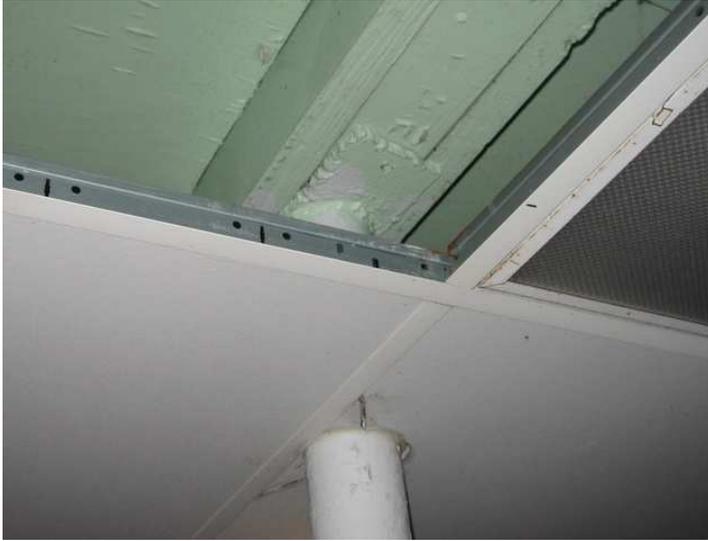
Figure 2-2 – Column Cap Plate

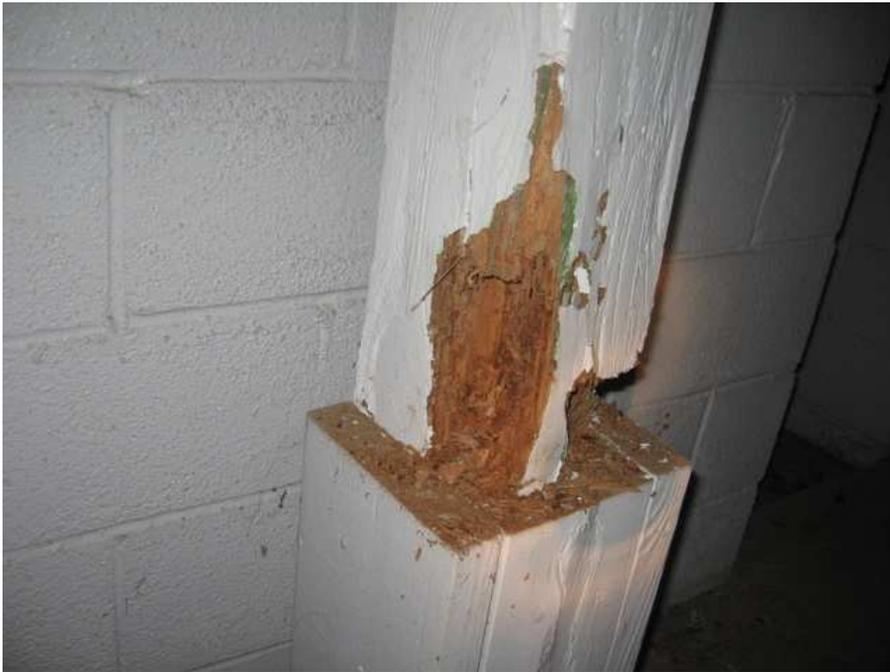
Figure 2-3 – Unsafe Wood Column

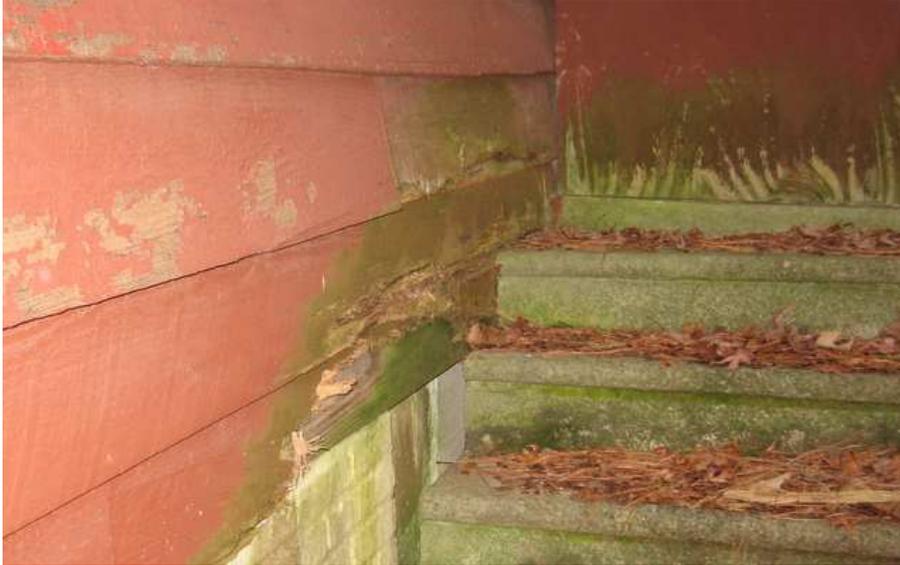
The exterior wall siding has water damage over much of the structure and is in need of complete replacement. The condition of the wall structure was not observed during this survey, however the damage presented by the siding and interior partition members indicates that a significant percentage of the wall sheathing and structural supports should also be replaced (Fig 2-4, 2-5, 2-6).

Figure 2-4 – Damaged Exterior Siding

Recommendation: The exterior stairs and associated railings should be replaced. The exterior frame and siding could be deconstructed and reconstructed using salvaged and new materials. However, it is more cost effective to replace the entire exterior frame and siding with new materials.

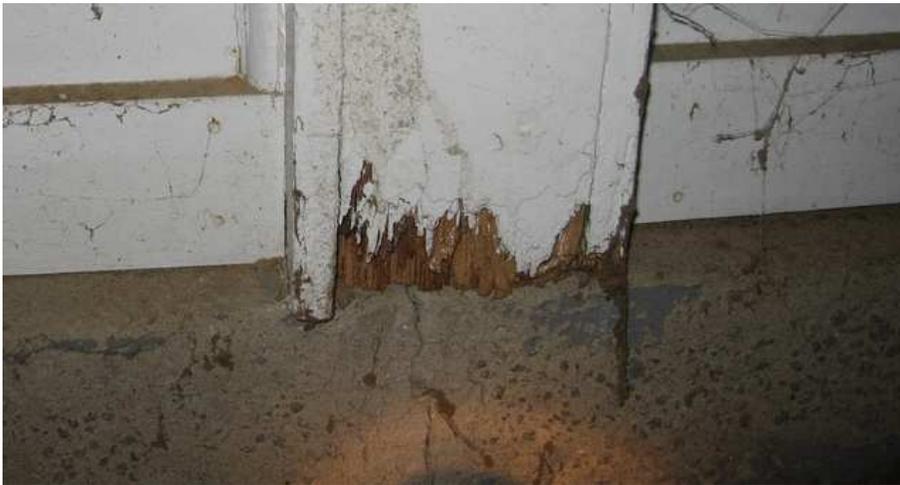
Figure 2-5 – Damaged Post at Exterior Wall

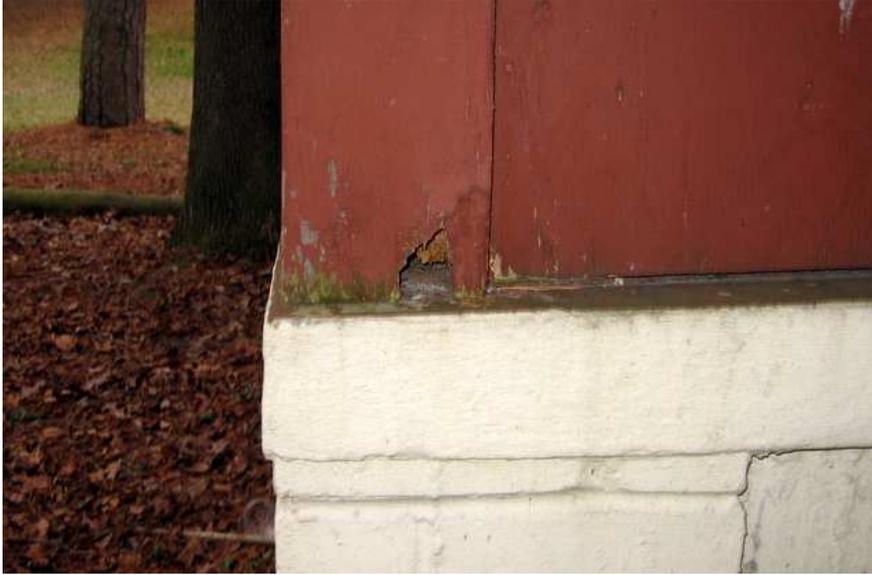
Figure 2-6 – Damaged Post at Exterior Wall

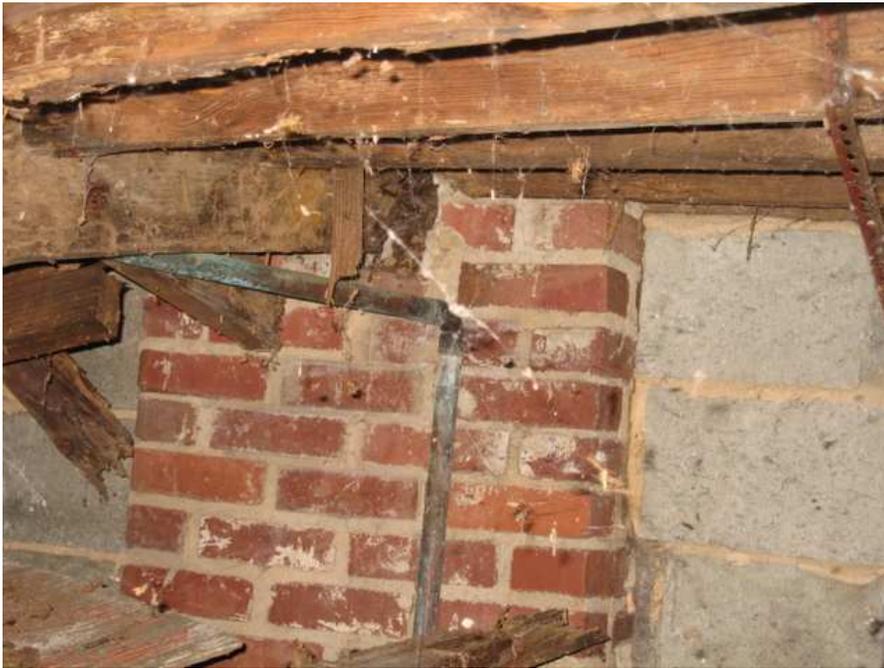
3. Concrete Floor Slab – The concrete floor found throughout the structure is cracked and spalling excessively in many locations on the interior surface. Examination of the underside of this slab shows that the original supporting timbers have rotted away (Fig.3-1, 3-2), leaving the slab to span between the exterior brick foundation piers and the interior column piers – a potential collapse hazard. The underside of the slab is also spalled in many locations with reinforcing bars exposed (Fig. 3-3, 3-4).

The current condition of the floor slab is inconsistent with supporting the 100 psf building code mandated live load for this structure. It is vital that this floor be reconstructed to meet this standard.

Figure 3-1 – Unsafe Condition, Floor Slab Support

Recommendation: The floor system should be fully rebuilt to with a new concrete floor system capable of supporting the building code mandated loads. This could be either an elevated concrete floor supported on masonry piers similar to the original (without the wood timbers) or a simple concrete slab-on grade foundation system.

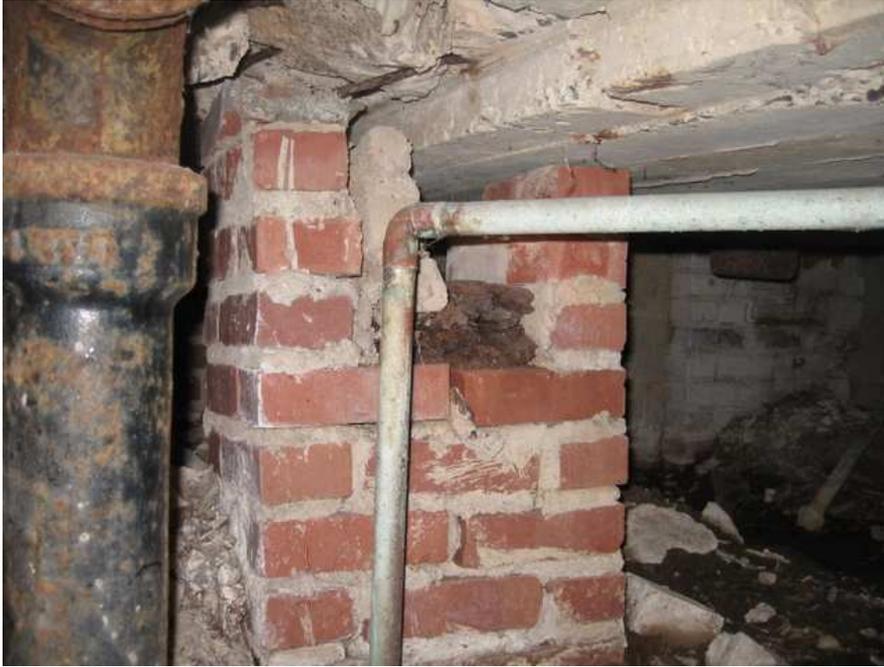
Figure 3-2 – Missing Floor Timbers

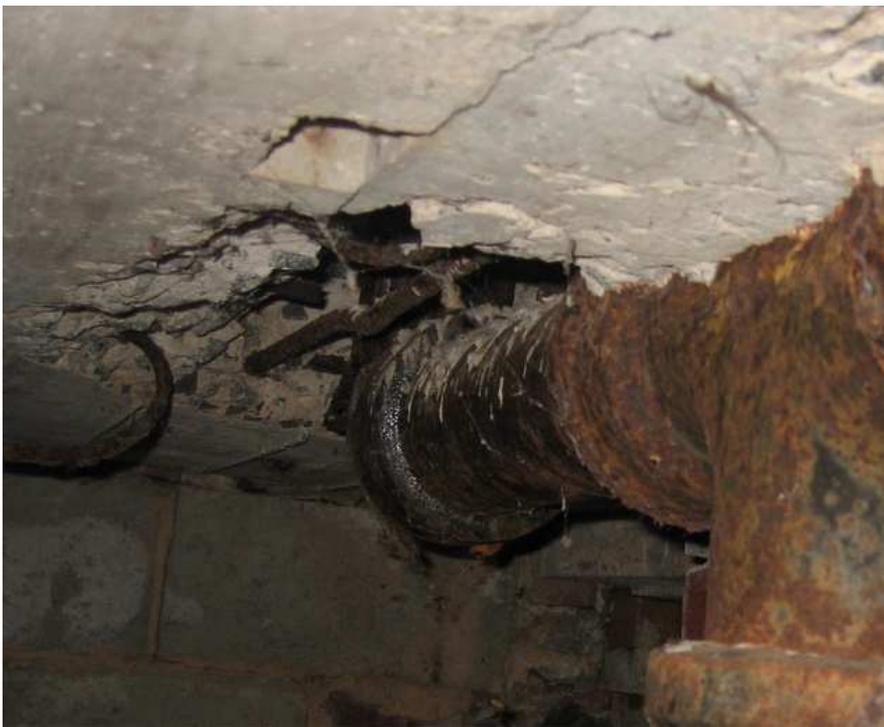
Figure 3-3 – Exposed Slab Reinforcing

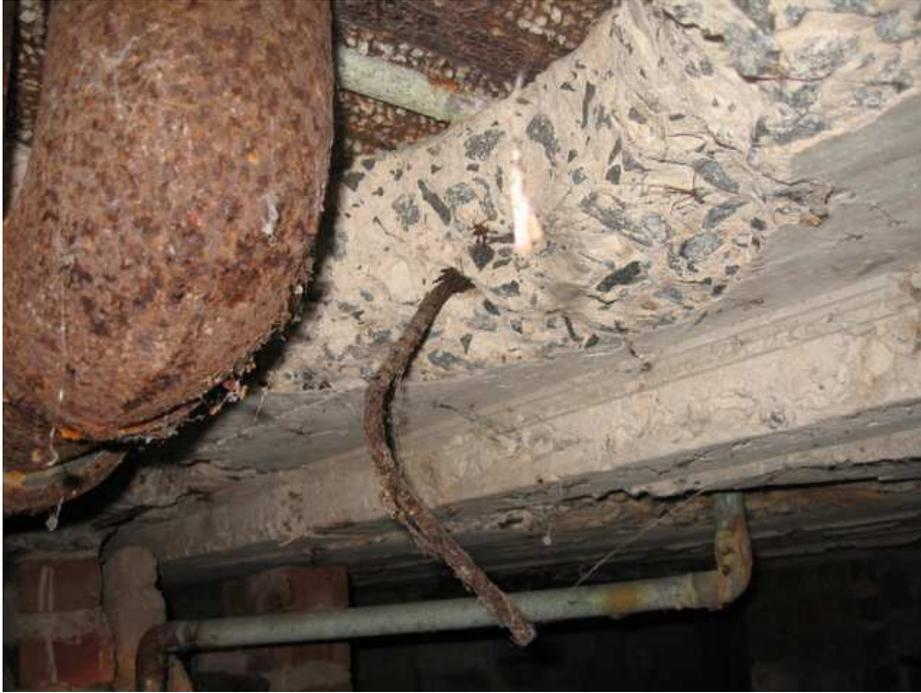
Figure 3-4 – Slab Reinforcing

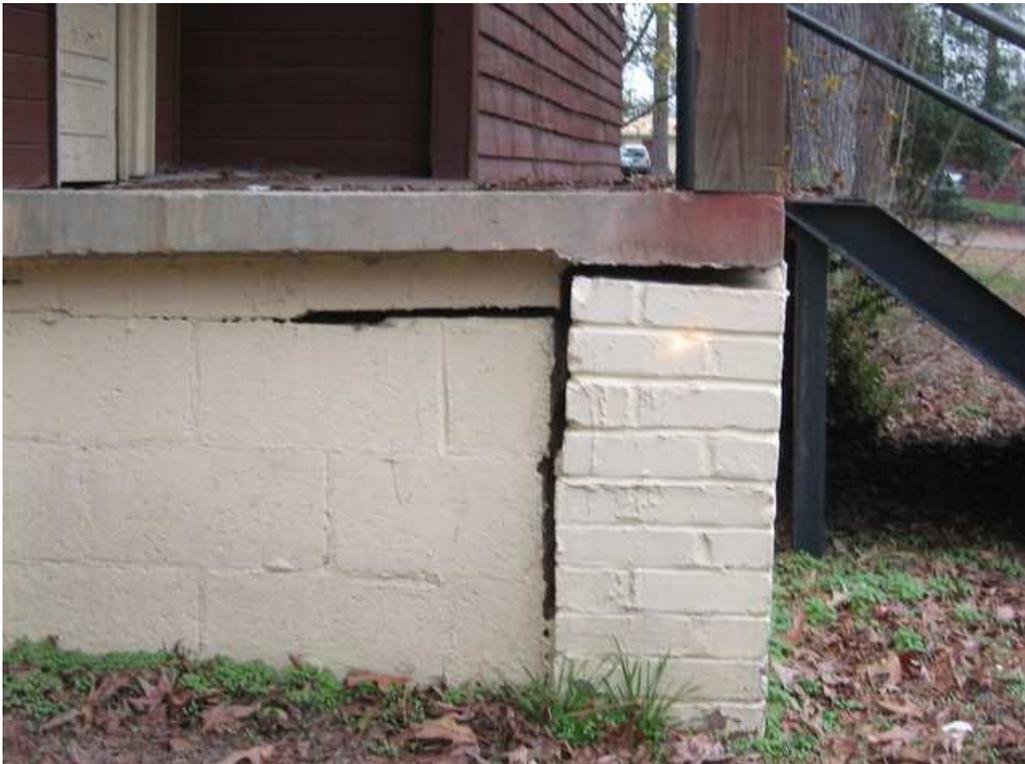
4. Building Foundations – Foundations for this structure are composed of brick masonry piers, likely supported on brick footings. Varying degrees of foundation settlement has occurred, leaving visible gaps between foundations and superstructure. This movement has caused the structure to visibly sag in some locations. Of particular note, gaps between the rear concrete entrance slab and foundation piers are greater than 1”; this slab has deflected (Fig. 4-1).

Figure 4-1 – Separation Between Entrance Slab and Foundation

Recommendation: The masonry foundation should be fully rebuilt to support the design loads or replaced with a new concrete slab on grade foundation system.

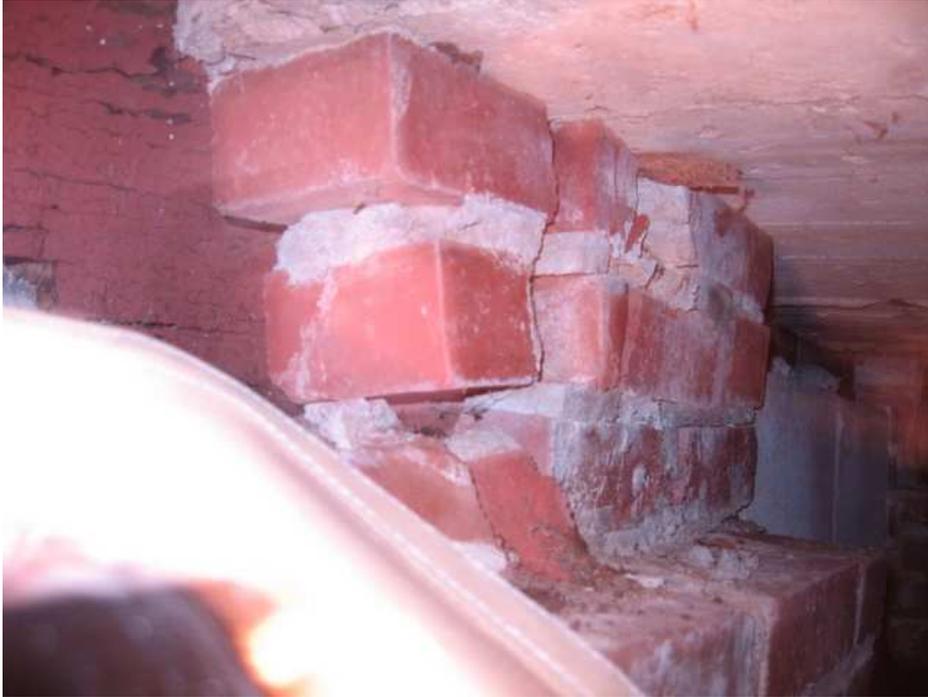
In addition, many piers have settled to an out-of-plumb condition and are not able to safely carry the design load. In some instances the brickwork is piecemeal in fashion (Fig 4-2, 4-3). Mortar joints have opened or are missing; Gaps between the piers and concrete slab are also present. To address these issues, a full foundation rehabilitation should be made in conjunction with the rebuilding of the concrete floor slab previously discussed.

Figure 4-2 – Slab Support Pier, Missing Mortar Joints

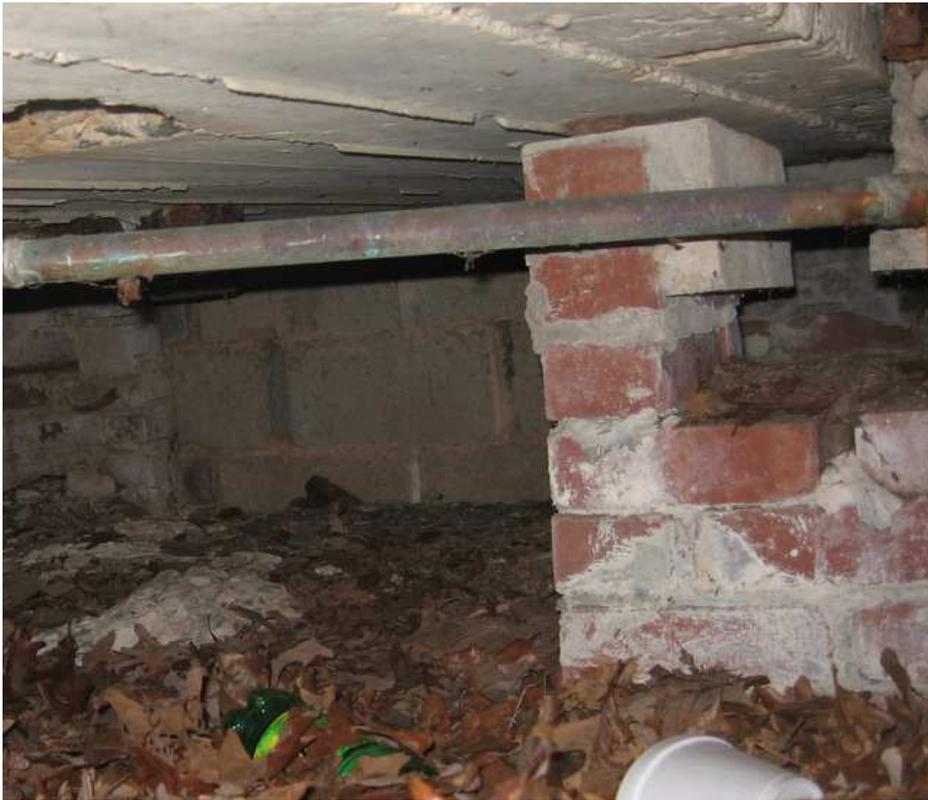
Figure 4-3 – Slab Support Pier, Piecemeal Construction
