Kimley-Horn  
and Associates, Inc.

June 8, 2011

Re: Property: Liberty Warehouse  
Site Observation of Storm Damage Report  
Location: 611/613 Rigsbee Avenue  
Durham, NC 27701

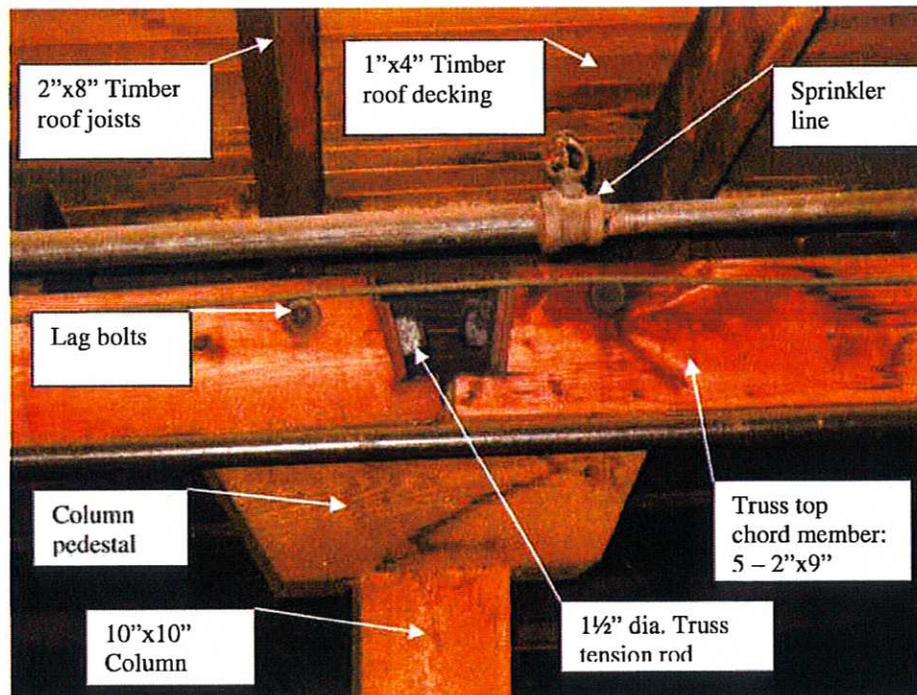
to span approximately 47' between column supports. Square timber columns, approximately 10" x 10" in section, provide support for the trusses at each end and transfer load to the foundation system below grade. Timber bracing (2" x 8") is located at each truss to column connection below the roof system and provides lateral stiffness to the warehouse structure. The primary structural members of roof framing are referenced in the photo shown below.

*Photo showing structural roof members (note braces not shown).*

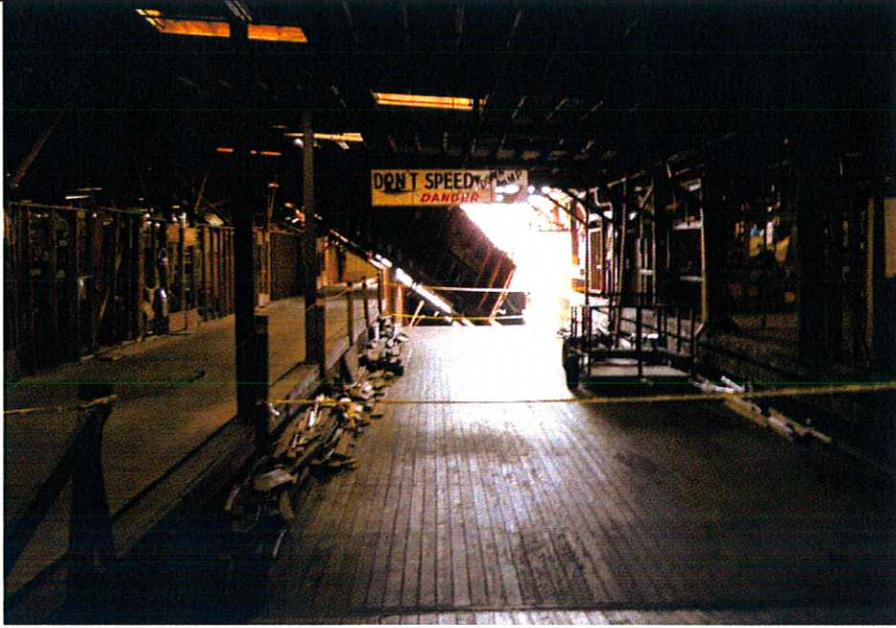
Photo No. 1

- An area of the warehouse roof structure of approximately 50' x 150' has collapsed onto an elevated walkway and central loading ramp. The failed structure was observed to be located above and partially covering tenant spaces number 14, 15, 16, and 17 in the 611 Rigsbee Avenue building. (Photos #1 - #4)
- The fallen roof structure is bearing on the elevated walkway handrail and interior wooden partition framing, which is used to separate tenant storage

Remarks: Overall photo of warehouse collapse showing extent of roof damage.

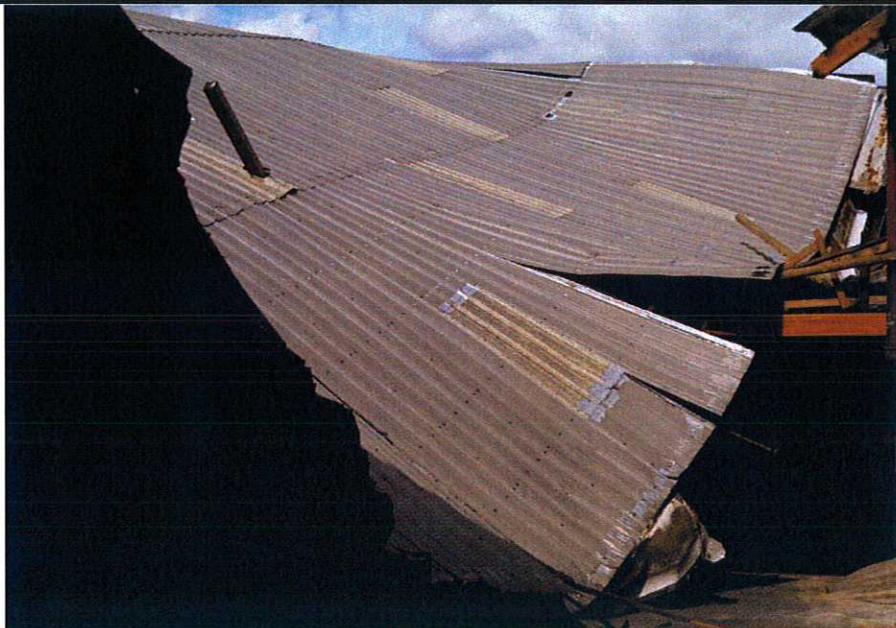
Photo No. 2

Remarks: Overall photo of warehouse collapse showing extent of roof damage.

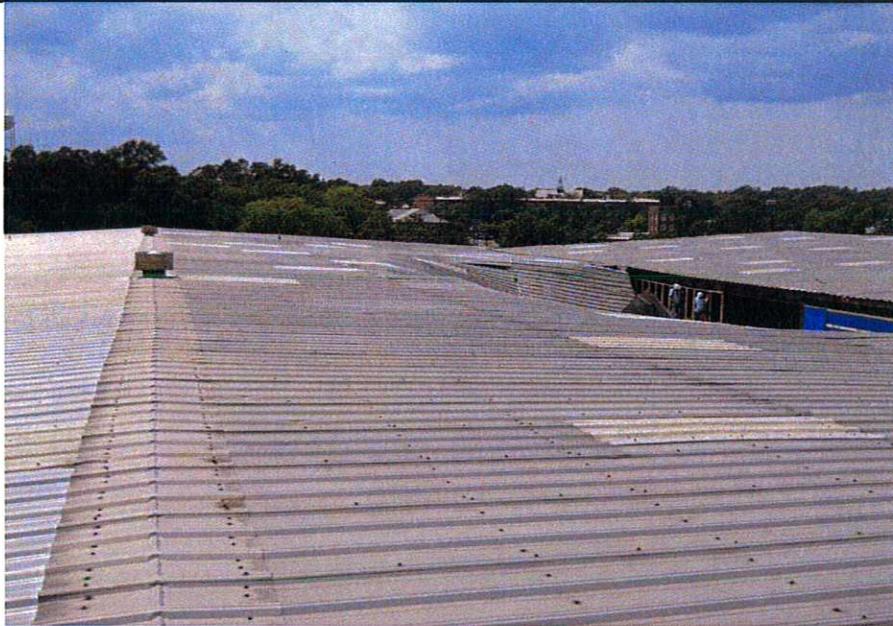
Photo No. 3

Remarks: Overall photo of warehouse collapse showing extent of roof damage.

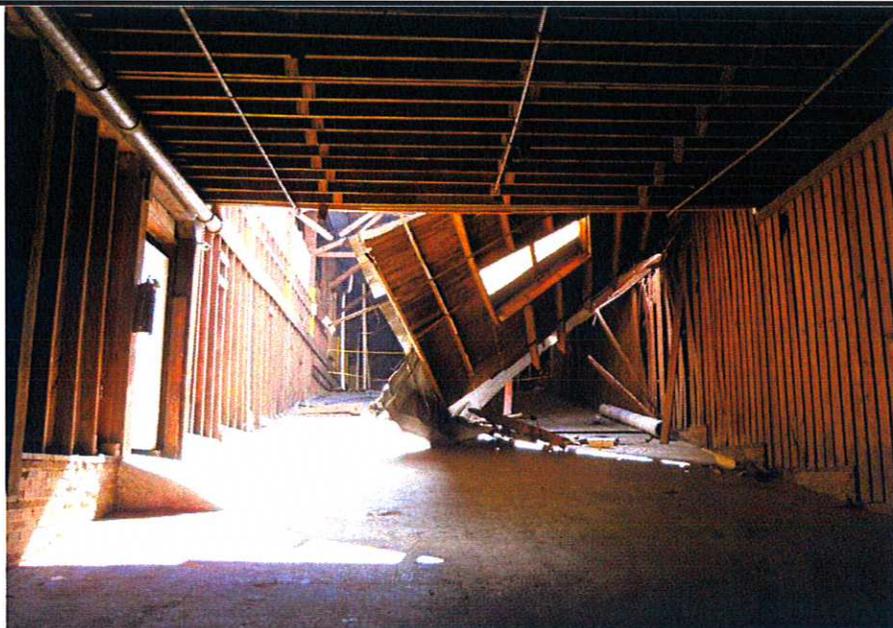
Photo No. 4

Remarks: Overall photo of warehouse collapse showing extent of roof damage.

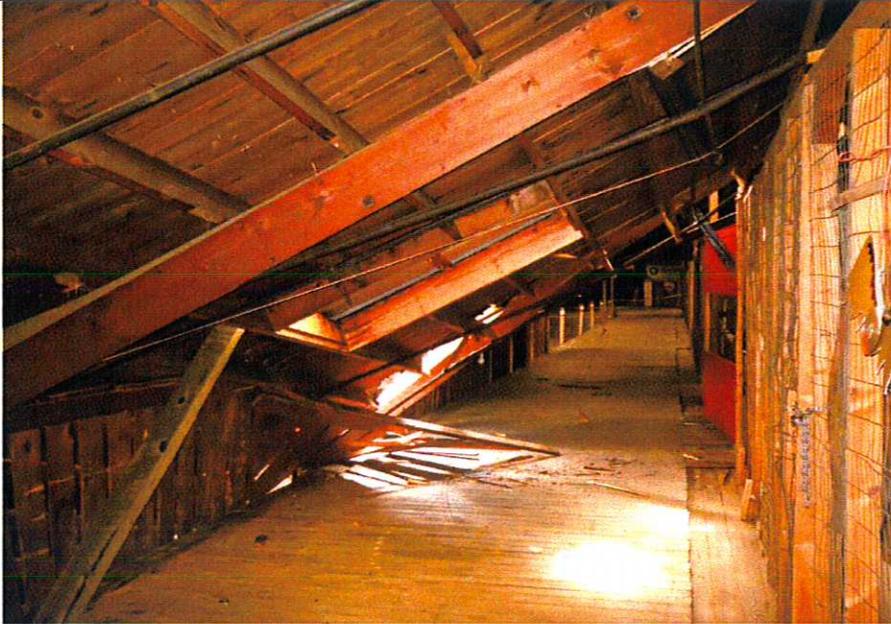
Photo No. 5

Remarks: Collapsed roof structure bearing on walkway handrail & partition framing.

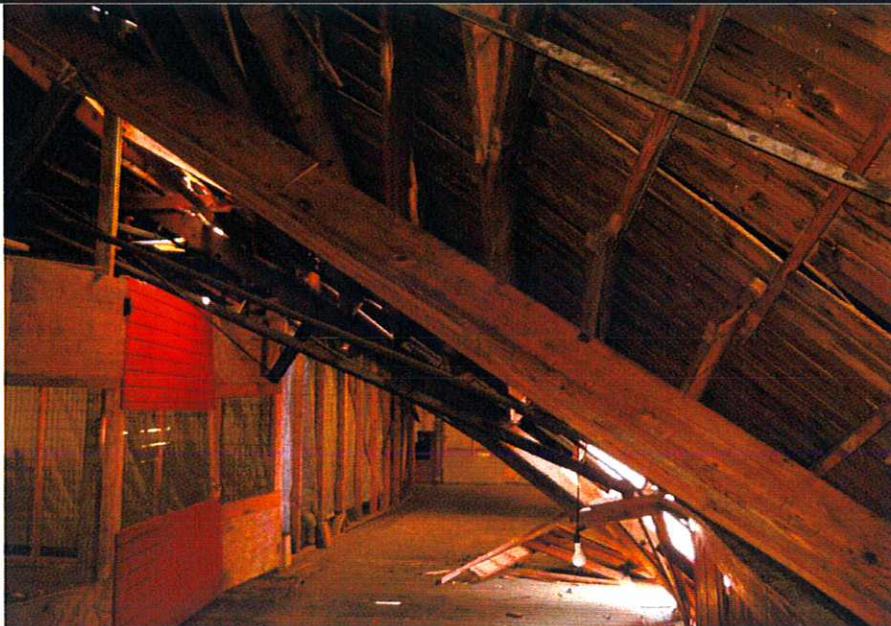
Photo No. 6

Remarks: Collapsed roof structure bearing on walkway handrail & partition framing.

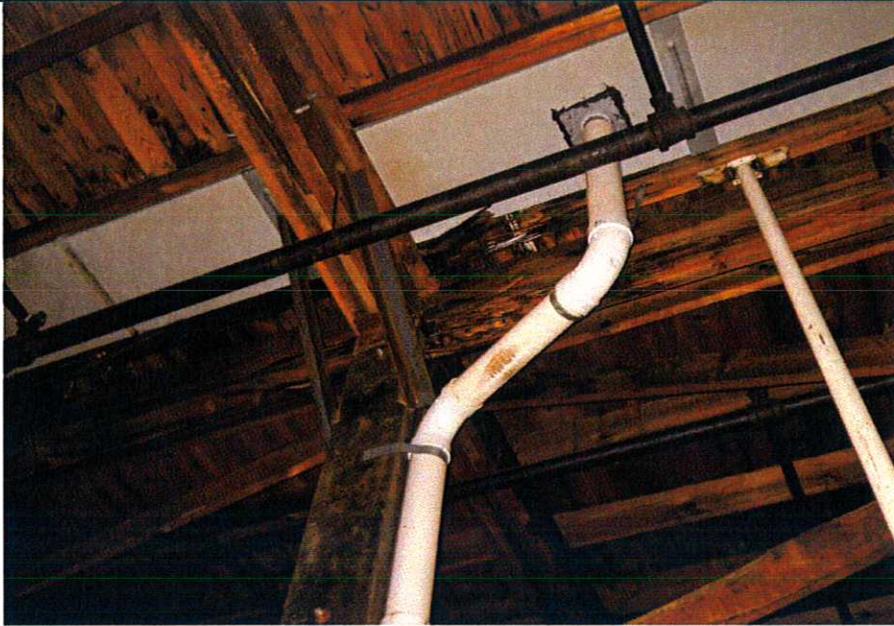
Photo No. 7

The two warehouse facilities, 611 and 613 Rigsbee Ave., are joined together by a central drainage gutter that is approximately 1'-6" in width and runs the full length of the warehouse. The underside of the gutter can be seen in Photo #7 in the photo sheet attachment. The central roof gutter is responsible for conveying rainwater from a roof area of approximately 95-ft x 370-ft (~35,150-SF). PVC roof piping, consisting of two 5-in diameter vertical risers and two 10-in diameter horizontal drainage pipes, collect the roof stormwater and distribute it to a basement level stormwater piping system. Refer to Photo #7 for the 5-in vertical PVC riser and Photo #14 for the 10-in horizontal PVC drain. It is our opinion that the quantity and size of the drainage piping originally in-use may have been insufficiently designed to support a surface area flow of this magnitude while also operating at an acceptable flow capacity.

Remarks: Roof gutter / drain adjacent to collapsed area.

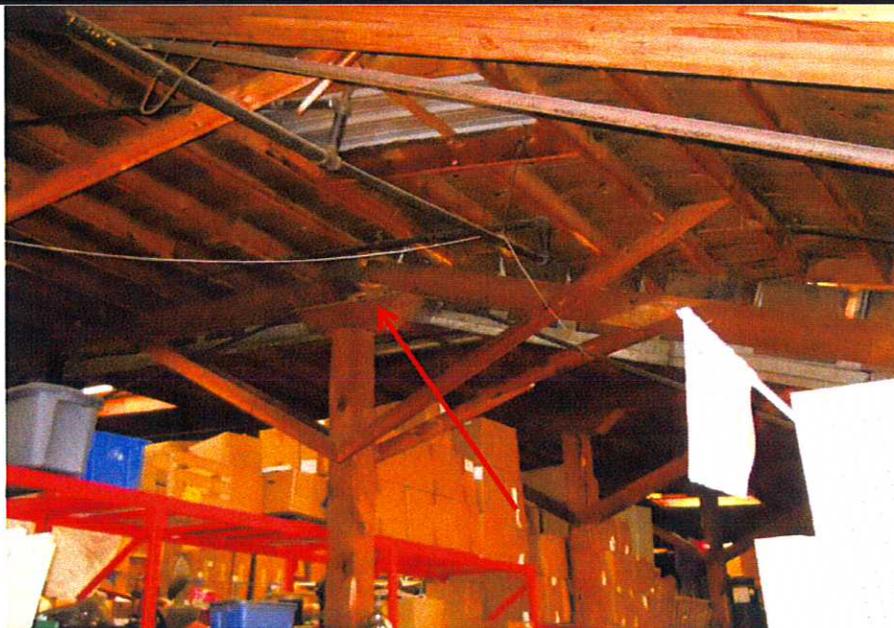
Photo No. 8

- spaces. (*Photos #5 – #6*)
- Significant wood deterioration was not observed in the failed structural members directly impacted by the storm event.
  - The long-span timber roof trusses have rotated off of their supporting column pedestals at multiple locations above the elevated walkway adjacent to the central loading ramp. (*Photo #8*)

Remarks: Roof truss top chord shown rotated off of column pedestal.

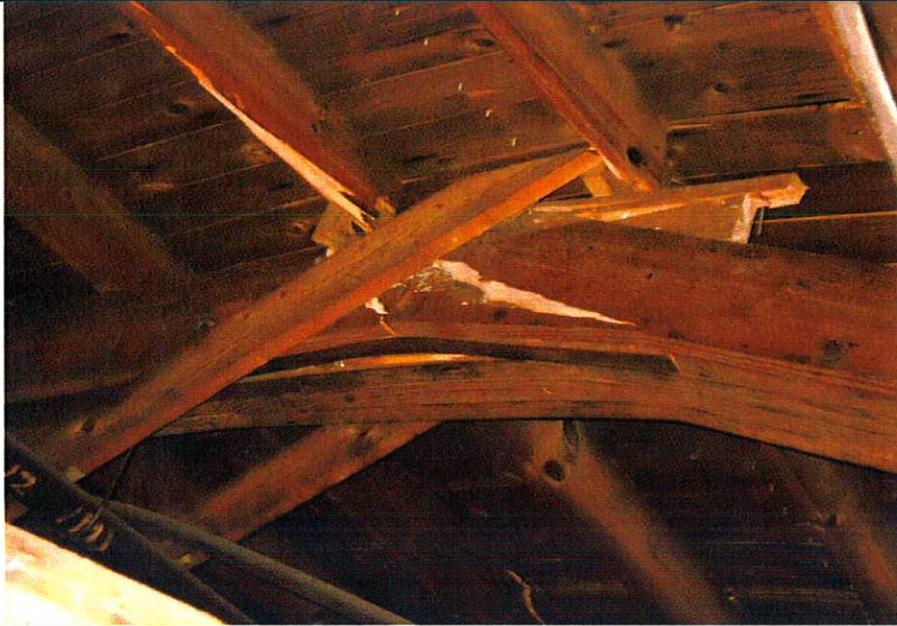
Photo No. 9

Remarks: Failed roof truss top chord shown damaged at brace connection.

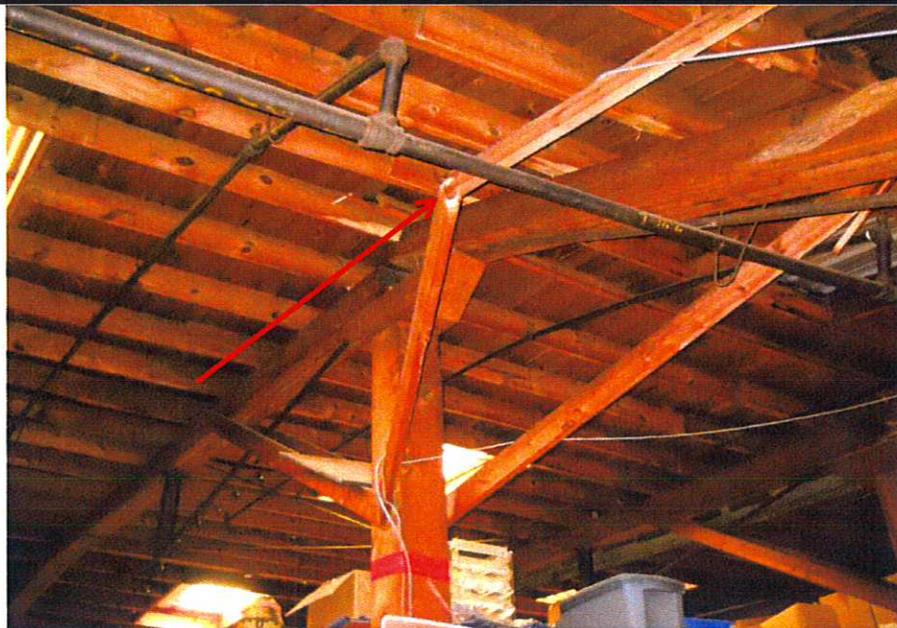
Photo No. 10

Remarks: Failed timber truss braces shown damaged.

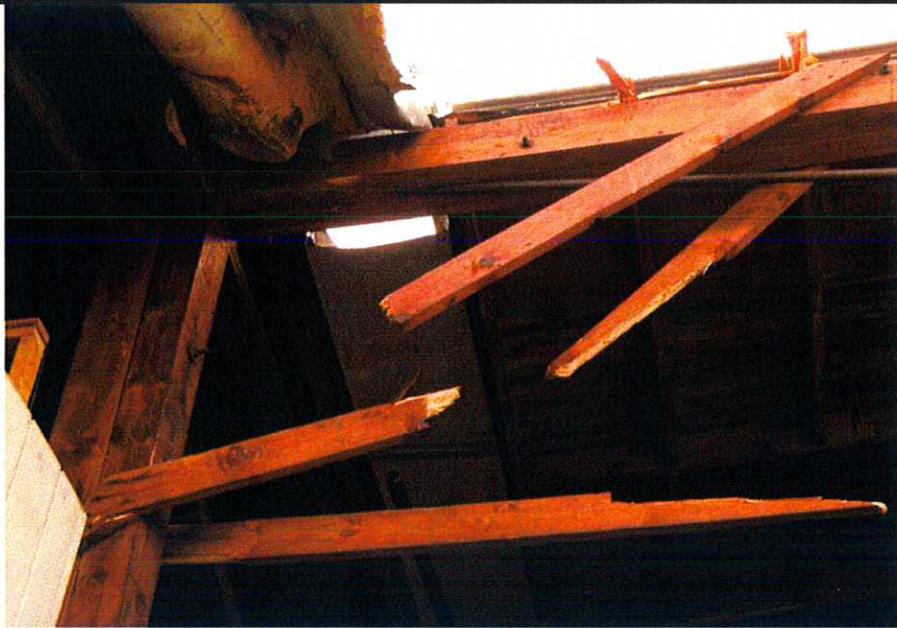
Photo No. 11

Remarks: Failed timber truss braces shown damaged.

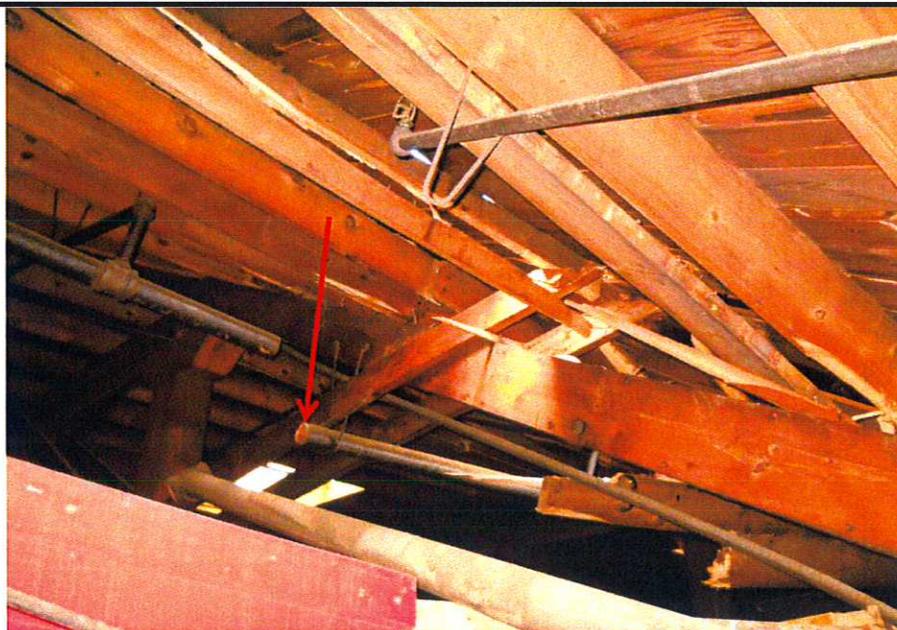
Photo No. 12

- Fire suppression sprinkler lines were observed to be severed due to the roof collapse. (*Photo #12*)
  - A portion of the gutter and associated 10” PVC drainage lines have been severed in the collapse. (*Photos #13 – #15*)

Remarks: Severed fire suppression sprinkler lines.

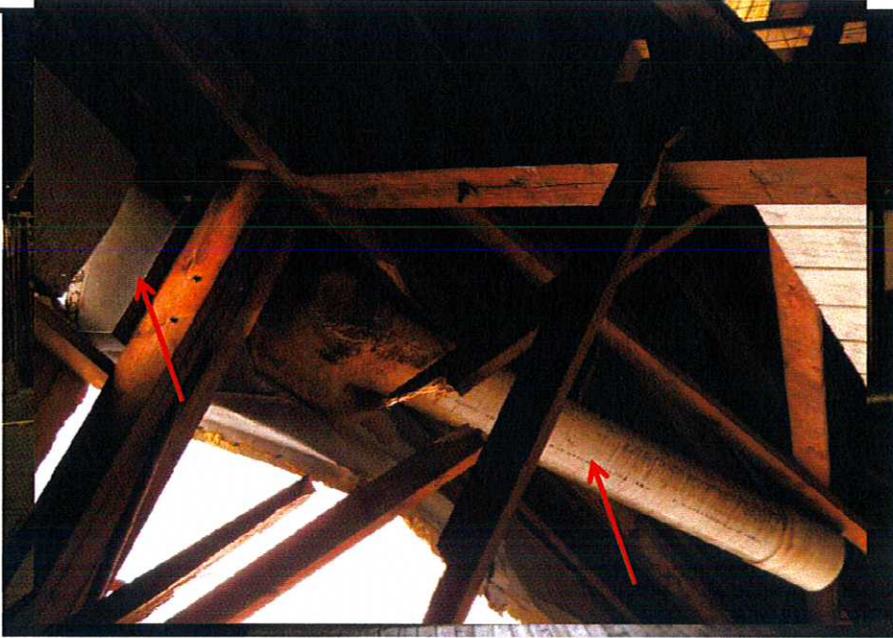
Photo No. 13

Remarks: Severed roof gutter and PVC drainage lines.

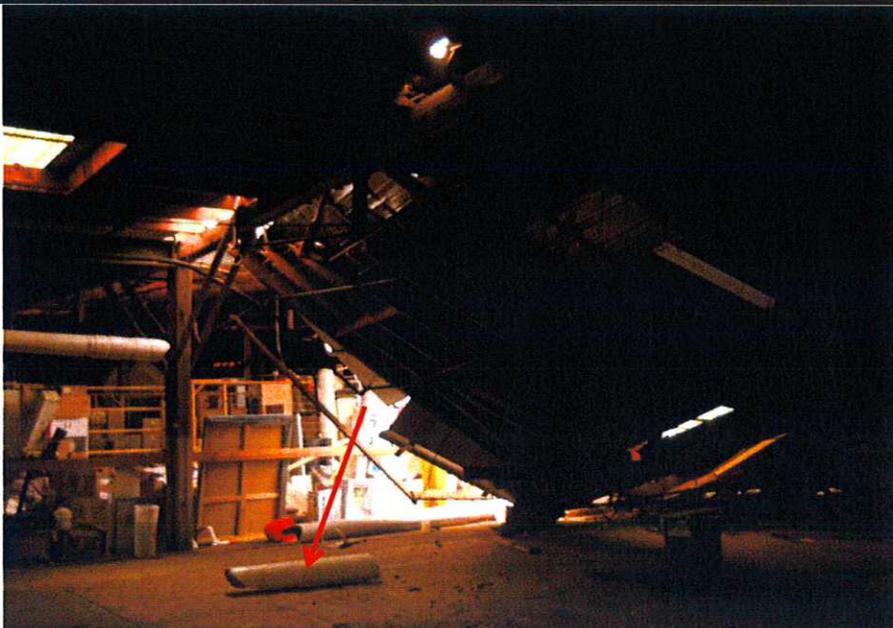
Photo No. 14

Remarks: Severed roof gutter and PVC drainage lines.

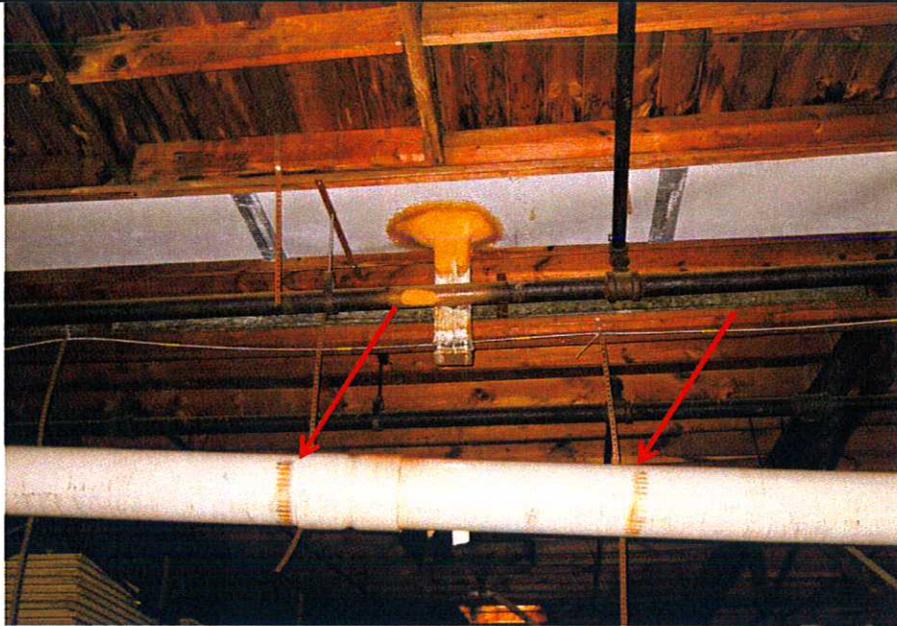
Photo No. 15

- structural support brackets to fail (Refer to Photo #15).
4. Failure of these brackets would likely have caused the drainage pipe to sag and to further restrict the ability of the pipe to gravity drain the stormwater. This event would have exacerbated the rate of water backing up on top of the roof and ponding on the roof structure.
  5. As the weight of ponding water exceeded the maximum limit of the roof structure capacity, failure of the roof structure occurred.

Remarks: Severed roof gutter and PVC drainage lines.

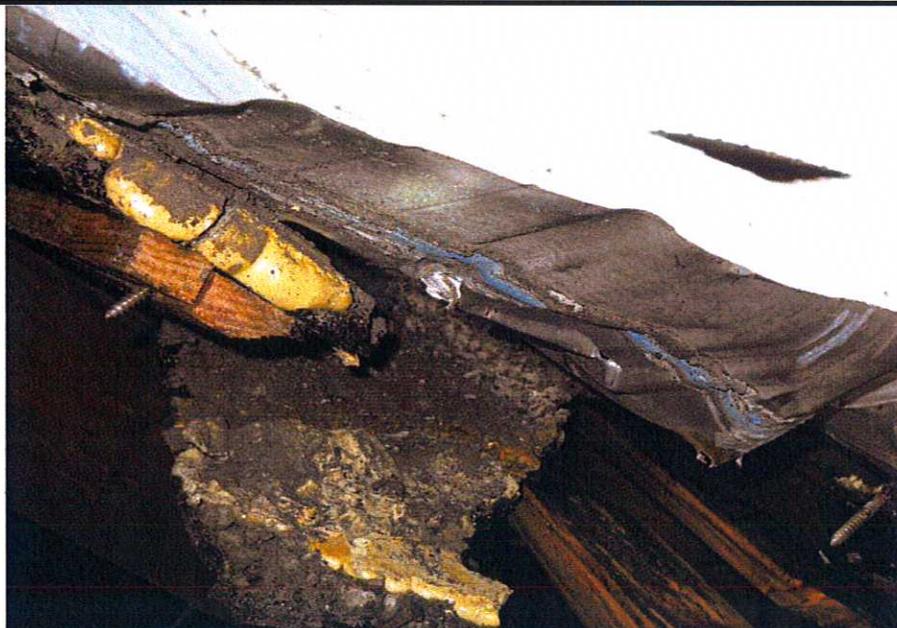
Photo No. 16

Remarks: Separated metal roof decking from previous asphaltic roofing material.

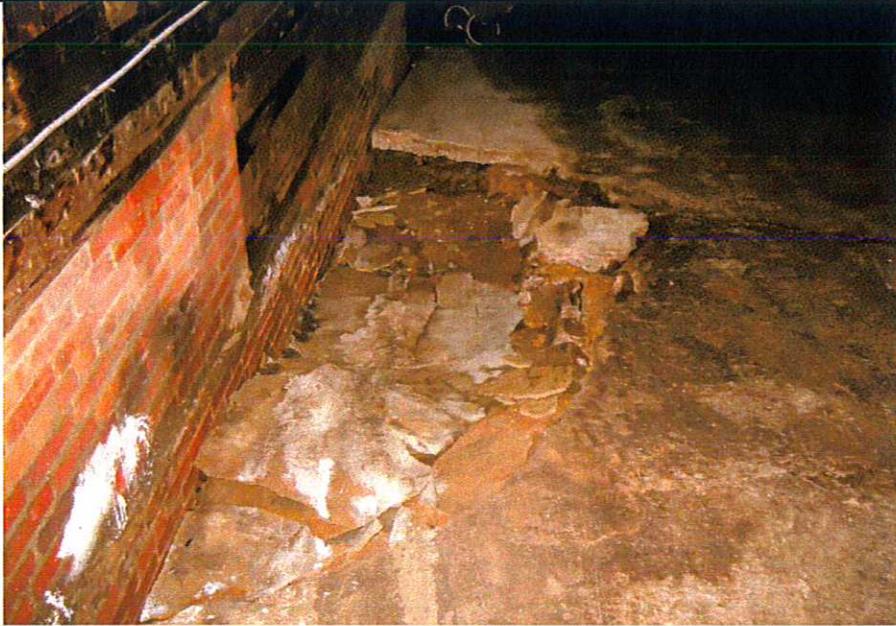
Photo No. 17

- The metal roof decking has separated from the timber roof decking, revealing the original asphaltic roofing system. (*Photo #16*)
  - Concrete slab-on-grade located at the Foster Street loading ramp was observed to have isolated areas of concrete failure and subgrade scour from stormwater damage. (*Photos #17 – #18*)

Remarks: Failed concrete slab-on-grade.

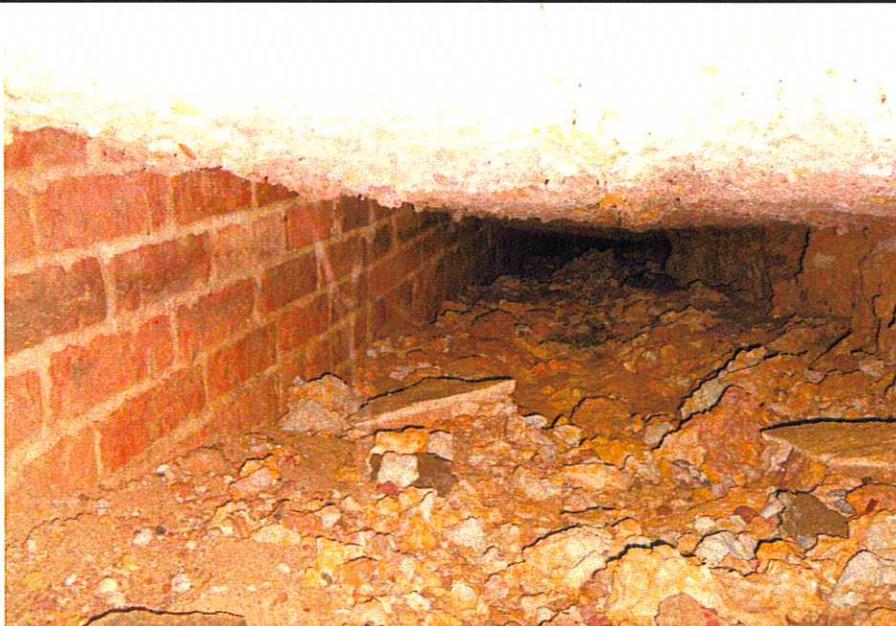
Photo No. 18

Remarks: Subgrade scour below failed concrete slab-on-grade.

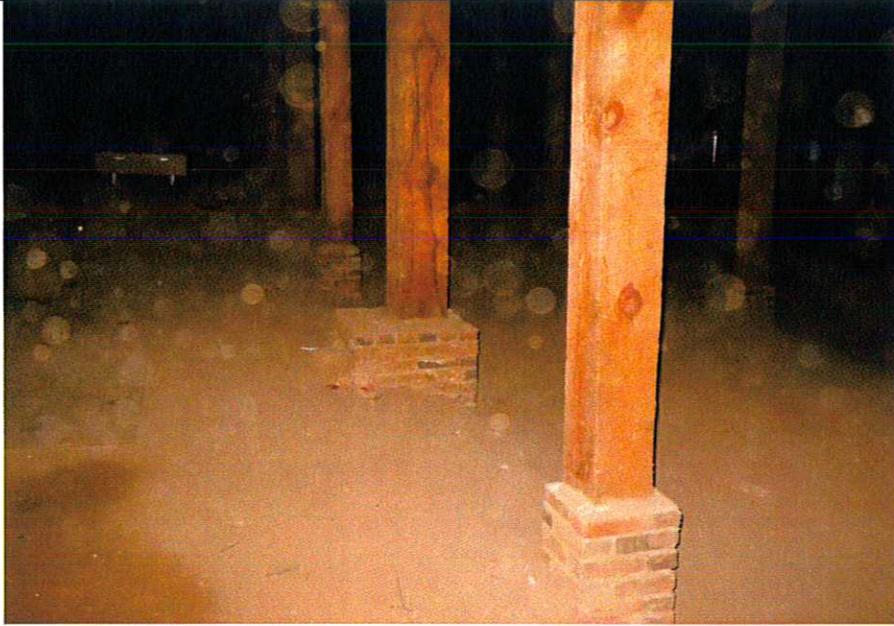
Photo No. 19

- The foundation system consists of built-up masonry pedestals supported by concrete footings. There was no significant storm related damage observed to the foundation system below the roof collapse area. (*Photo #19*)

Remarks: Columns and foundations below area of collapse.

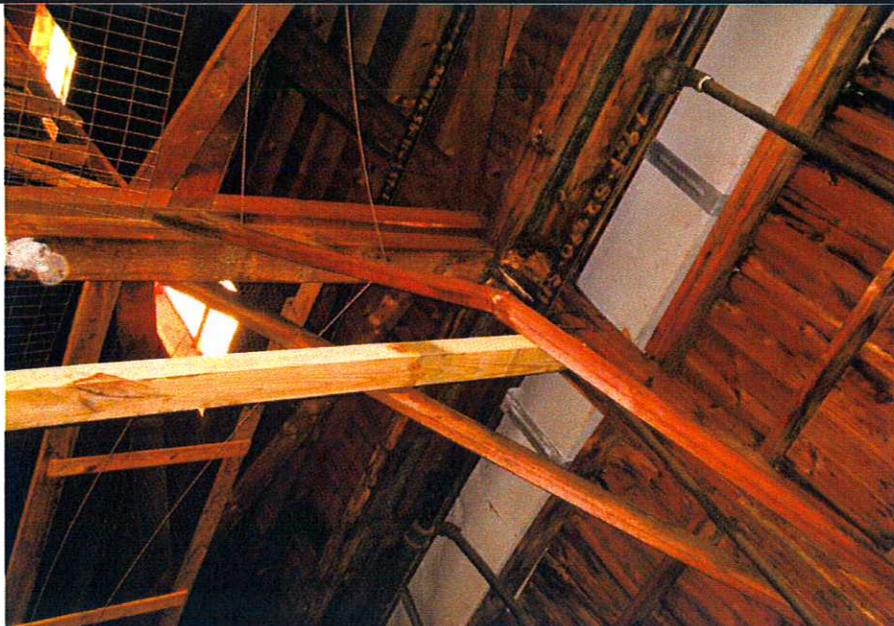
Photo No. 20

- Temporary shoring, consisting of 4” x 4” timber posts, was observed at several locations supporting timber trusses located directly below the existing roof gutter. Based on information gathered at the time of the site visit, the shoring was installed in the adjacent bays immediately after the roof collapse. (*Photo #20*)

Remarks: Temporary shoring installed below timber roof trusses.
