EXHIBIT B – Report for Asbestos Inspection and Universal Waste Assessment Services

**Reference: Report for Asbestos Inspection and  
Universal Waste Assessment Services**  
Demolition of Water Management Structures  
Nine Parcels near Lake Michie and Other Locations  
Bahama and Durham, North Carolina  
S&ME Project No. 5358-14-072

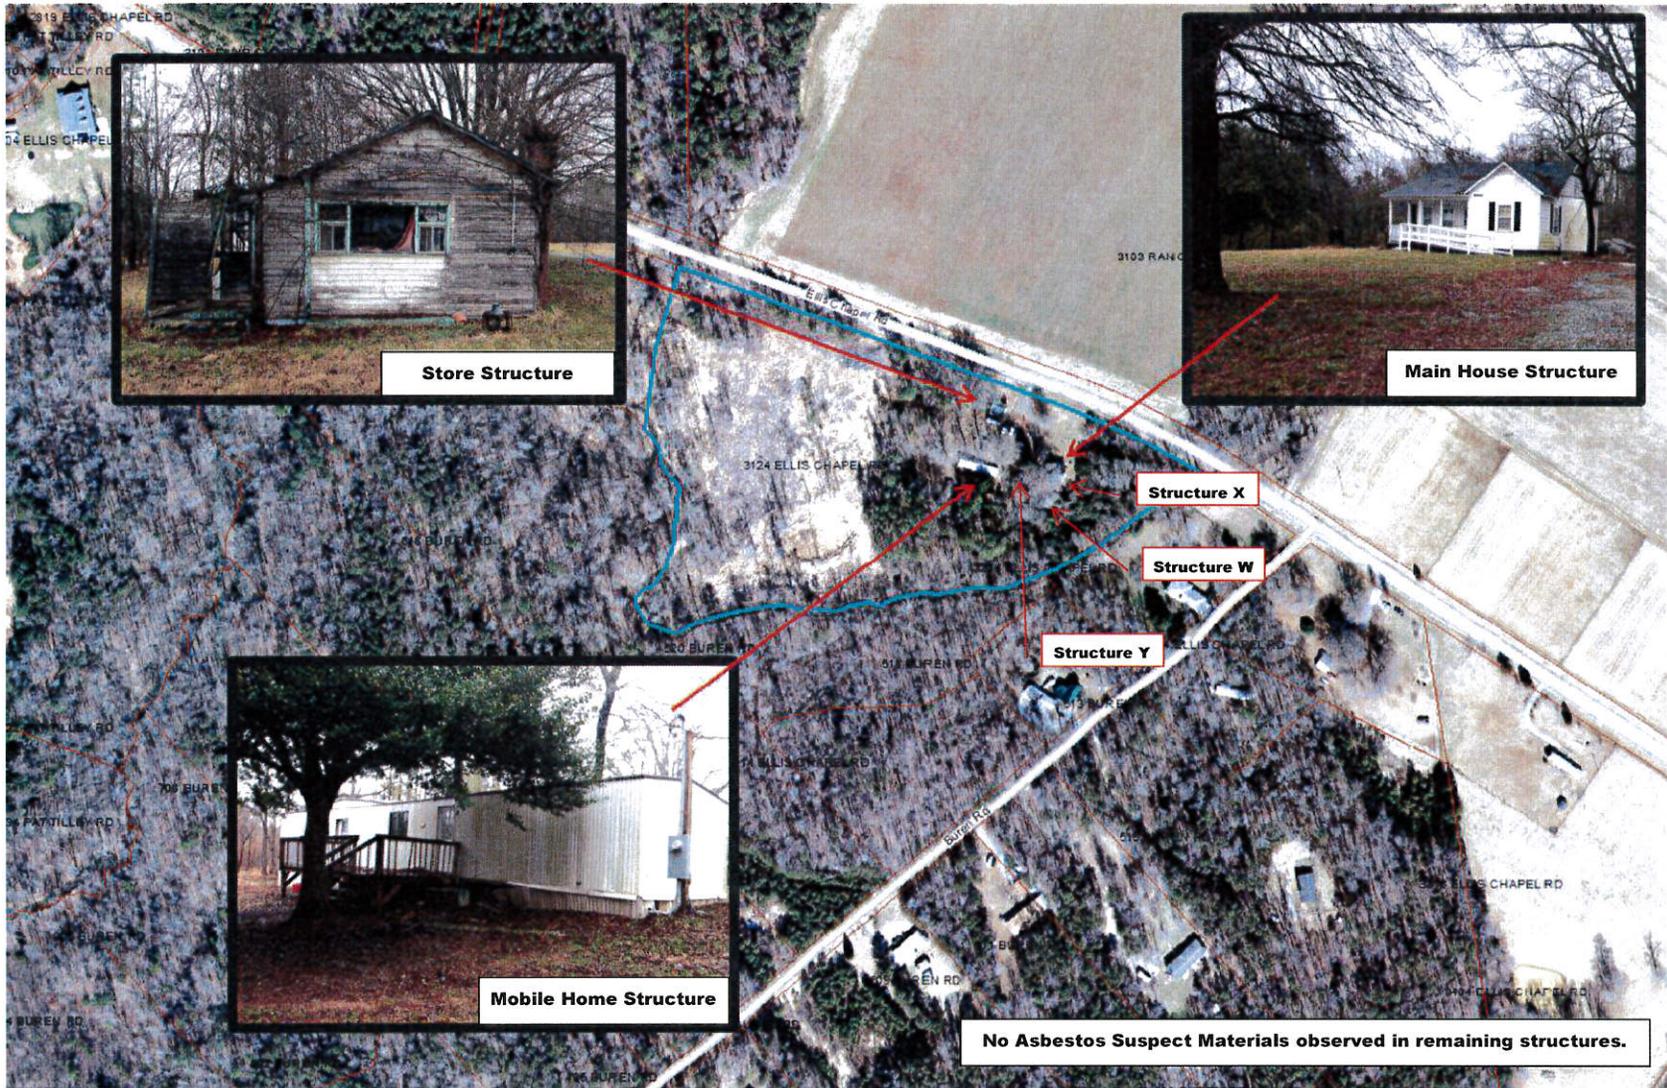
Figure F-1 Structure Locations  
3124 Ellis Chapel Road, Bahama, NC

Name	Description and Location	Approximate Size (SF or LF)	Category <sup>1</sup> (F/I/II)	Condition <sup>2</sup> (PD/PSD/D/SD)	Number	Sample Location	Type and Percent Asbestos
W	Asphalt roll roofing under tin shed W (See Figure F-1)	300 SF	F	D	W-3124-48	Tin Shed W	Shingle 1 - ND Shingle 2 - ND Felt - ND
					W-3124-49	Tin Shed W	Shingle 1 - ND Shingle 2 - ND Felt - ND
X	Asphalt roll roofing under tin shed X, directly behind main house (See Figure F-1)	200 SF	F	D	X-3124-50	Tin Shed X	Shingle 1 - ND Shingle 2 - ND
					X-3124-51	Tin Shed X	Shingle 1 - ND Shingle 2 - ND
Y	Asphalt roll roofing under tin shed Y only under A frame section (See Figure F-1)	300 SF	F	D	Y-3124-52	Tin Shed Y	Shingle 1 - ND Shingle 2 - ND
					Y-3124-53	Tin Shed Y	Shingle - ND Felt - ND
AA	1'x2' ceiling tiles in Store Building	300 SF	F	SD	AA-3124-56	Debris Sample - Inside Store	ND
					AA-3124-57	Debris Sample - Inside Store	ND
