# LOCAL HISTORIC LANDMARK APPLICATION

## Attachment 1: Written Description for Historic Landmark Application

EAST DURHAM GRADED SCHOOL /  
 The HISTORIC Y. E. SMITH SCHOOL  
 107 S. DRIVER STREET, DURHAM, NORTH CAROLINA

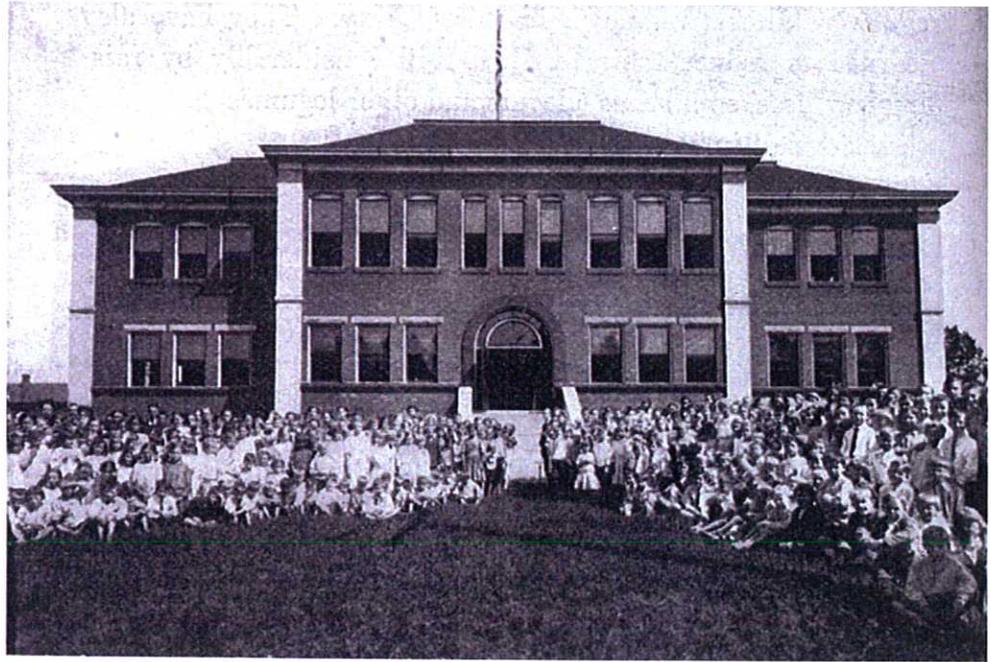
The 1909 brick structure (inset at right; source Open Durham) is a two story building with a habitable basement level replete with windows and direct access to the exterior. Consisting of a primary west/street-facing volume flanked symmetrically on the north and south by two subordinate wings, the building

has large double-hung windows and a tall fascia with deep, guttered overhangs at the edges of hipped roofs. The building's corners are beige-colored brick pilasters with a projecting detail at the level of the 2nd floor, and the facades are uniform, orange-colored brick that is typical of the region. The 1st floor windows feature stone lintels, while the 2nd floor windows have masonry arched tops, and the basement windows are square-headed and without an expressed lintel detail. There is a water-table detail running horizontally around the building at the level of the 1st floor window sills.

The symmetrical, primary Driver Street façade has nine windows at the 2nd level, over six total windows flanking a large arched opening for the front door to the school. The three center 2nd floor windows above the arched opening are narrower in width than the other windows in the façade. There is a straight run set of brick-walled steps leading to the front door and arched opening from grade. The subordinate wings have three windows at each floor level, including the basement. The window frames were originally, and remain today, white in color. The side elevations are very similar to the primary, street facing façade, including a center-placed arched opening on each side.

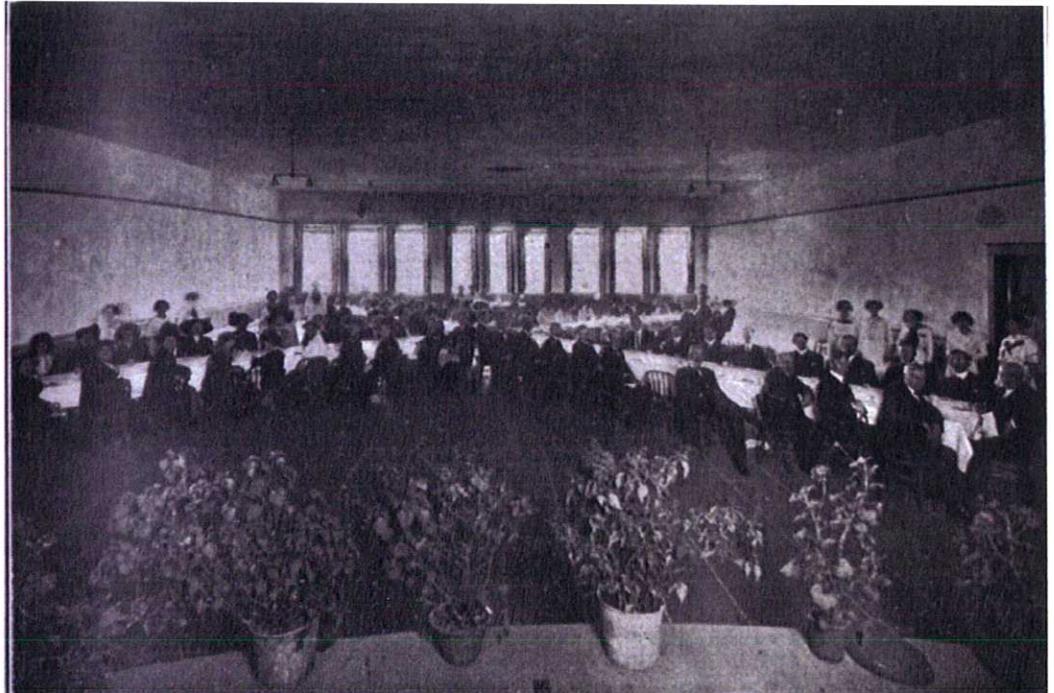
The interior of the school has at least three distinctive architectural features. First, and most stunning, is the large, level-floored auditorium that occupies the front middle of the 2<sup>nd</sup> floor. This auditorium (photo from the 1910s inset at right; source Open Durham) dates to the original 1909

construction and is the defining feature of the building's interior, featuring a stage at the east (windowless) side of the room and large amounts of natural light flooding in from the nine front/west-facing windows. The original maple floors remain in very good condition, except for the area that used to be the stage (and will again upon restoration), which was destroyed from severe water damage caused by a sizable hole in the roof. The rest of the auditorium is much as it was when built in 1909, and will be a tremendous asset to the generations of children who will attend the school in the future. Self-Help's tenant, Maureen Joy Charter School, intends to use the space for performances, public functions and school assemblies, much as the space was originally intended by architect Fred Githens.

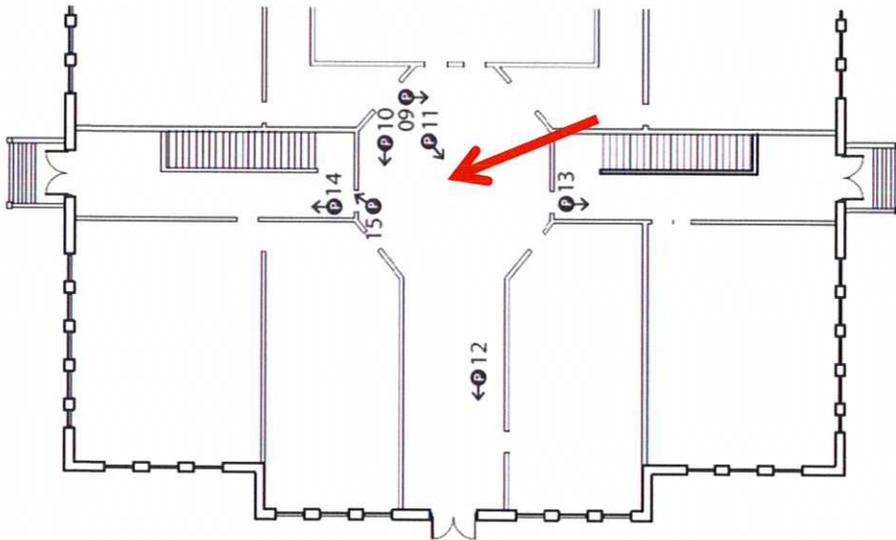
Second, the original 1909 building features an unusual octagonal main lobby (illustrated at left) that has three corridors leading directly into it: the route to the front/west-facing door, and parallel side entrances from the north and south. Off of this octagonal lobby sit

administrative offices, classrooms and defining staircases that access the 2<sup>nd</sup> floor classrooms and auditorium.

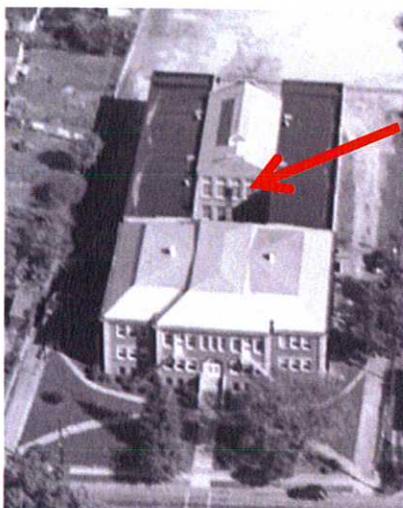
Finally, as noted above, once the building's wings were added in 1920 the school featured an open-air courtyard (pictured at left in a 1950s era photo). This courtyard was a unique distinguishing feature of the school until it was enclosed at a later date (date unknown but likely 1960s) to maximize interior square footage.

As shown in the Part 2 Historic Tax Credit application that is attached to this document, Self-Help will be re-opening the courtyard as a signature piece of its restoration plans. This will bring one of the key historic elements of the building back into place, and will also supply natural light to interior corridors, offices and classrooms. Undoubtedly, this feature will—as it did nearly 100 years ago—be a distinguishing element of the school's design.

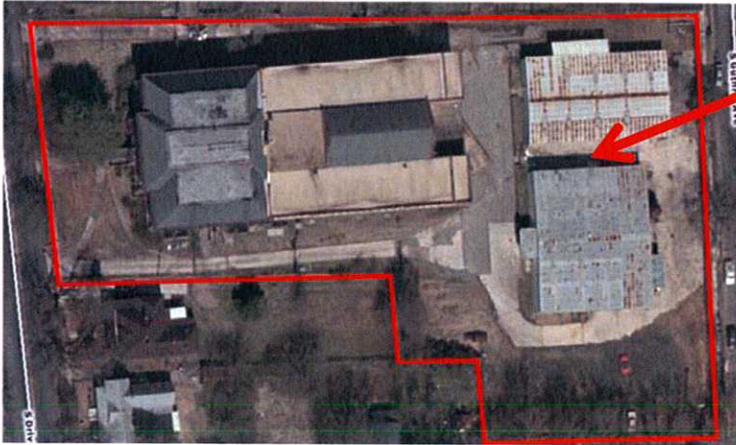
Most prominently, two metal storage sheds were added to the back third of the site (see above aerial photo from current day tax records) sometime circa 1980. These storage sheds are not historic and had nothing to do with the school use of the site; they were added during the Durham Exchange Club's use of the property. The sheds were put on a part of the lot that previously was used by the school as open space/playground area and parking. Self-Help's site plan restores the original use of that important part of the property.

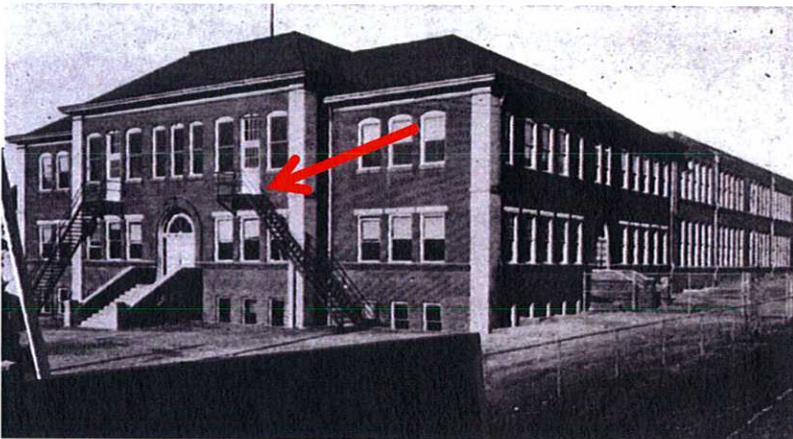
building's early history fire escapes were affixed to the front façade of the building (see inset photo from 1926; source Open Durham), presumably when the wings to the building were added in 1920. The fire escapes were affixed to modified windows that deviated from the original 1910 design, and lasted through at least the 1950s. By 1970 (and perhaps earlier), they were gone and the windows that had been used for the fire escapes were back to their original look.

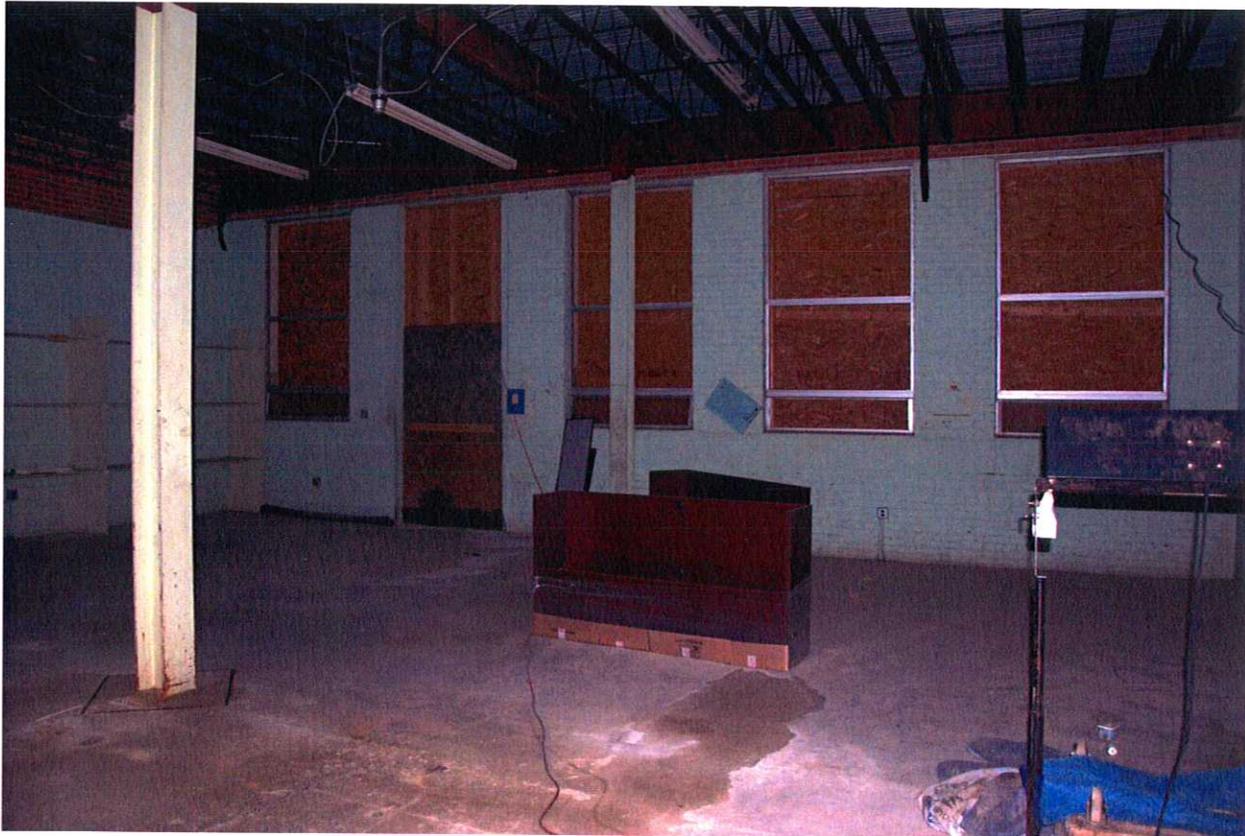
First Floor Old Courtyard – Roof to Be Reopened to the Sky

<p>Photo no. _____ Drawing no _____</p>		
<p><b>Number</b> <b>8</b></p>	<p>Architectural feature <u>OPEN-AIR COURTYARD</u></p> <hr/> <p>Approximate Date of feature <u>1930</u></p>	<p>Describe work and impact on existing feature: Courtyard will be resorted to be an open-air breakout and study space. The intermediate 2<sup>nd</sup> floor will be demotoished as will the roof. All infill masonry in window openings will be removed and replaced with new energy efficient windows to match the historic pattern. Two new windows on the North and South walls of the courtyard on both the 1<sup>st</sup> and 2<sup>nd</sup> story will be added. New windows will be the same size and style as original windows in the same wall.</p>
<p>Describe existing feature and its condition: Between 1920-1937, a two-story 'gym' bldg. was added in between the two classroom wing additions. The gable-roofed, steel-trussed gym volume was installed midway (east-west) between the original building and the east ends of the classroom wings, creating an open-air courtyard between the original school, the classroom additions, and the new gym. At some point, the open-air courtyard was roofed-over and sectioned horizontally with new 1<sup>st</sup> and 2<sup>nd</sup> floor infill construction. The former window openings looking into the courtyard, except for those on the 2<sup>nd</sup> floor east, wall have been bricked closed. The 1<sup>st</sup> and 2<sup>nd</sup> infill floors are concrete slab on steel joists, and remain in good condition. The roof is a flat/low-slope roof.</p>

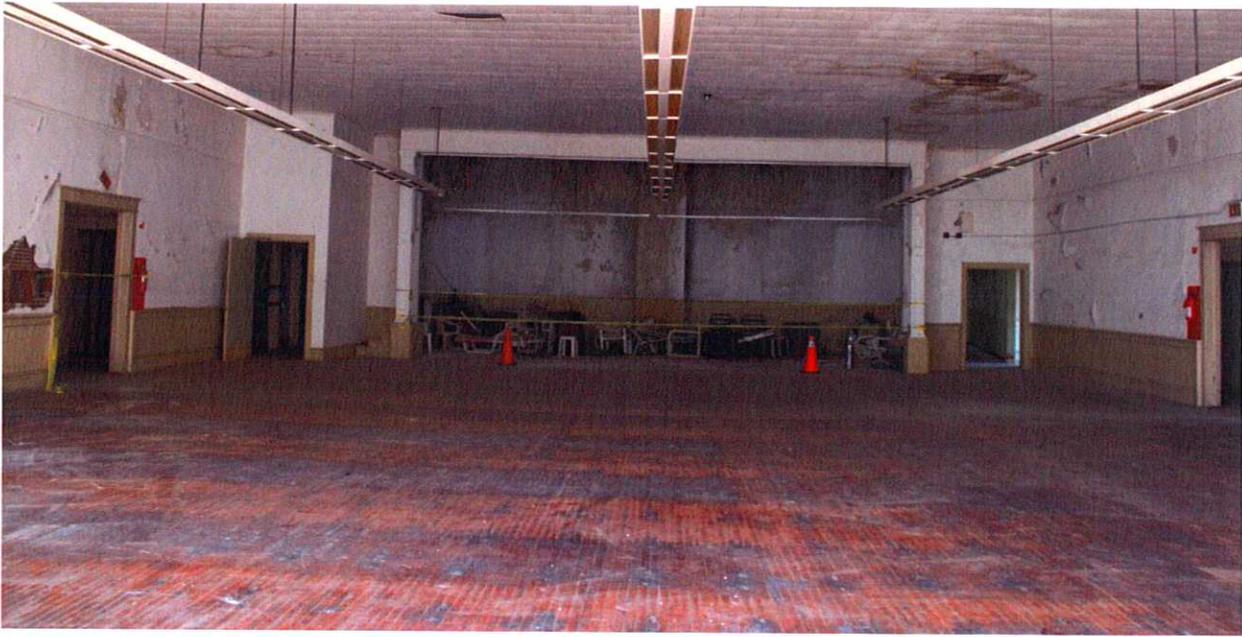
Second Floor – Auditorium

<b>Number 13</b>	Architectural feature <u>CLEAR-SPAN AUDITORIUM SPACE, 2<sup>ND</sup> FLOOR</u>	<p>Describe work and impact on existing feature: The space will remain open and unobstructed for use as an event space. The hardwood floor will be repaired with salvaged flooring from elsewhere in the building, and will remain exposed as the finished floor material. A new acoustic ceiling will be installed to update the the worn, failing ceiling that currently exists in the space, beneath the roof trusses.</p>
	Approximate Date of feature <u>1910</u>	
<p>Describe existing feature and its condition: The 2<sup>nd</sup> floor event space occupies the center of the 2<sup>nd</sup> floor of the original 1910 building, and it remains in fine condition save for some water damage due to roof leaks. The vast majority of the hardwood floor remains. Steel roof trusses span the 50-foot-wide room leaving it open and unobstructed by structural columns. The existing exterior windows at the west wall (front façade of the school) remain open, providing the considerable space with ample daylight.</p>

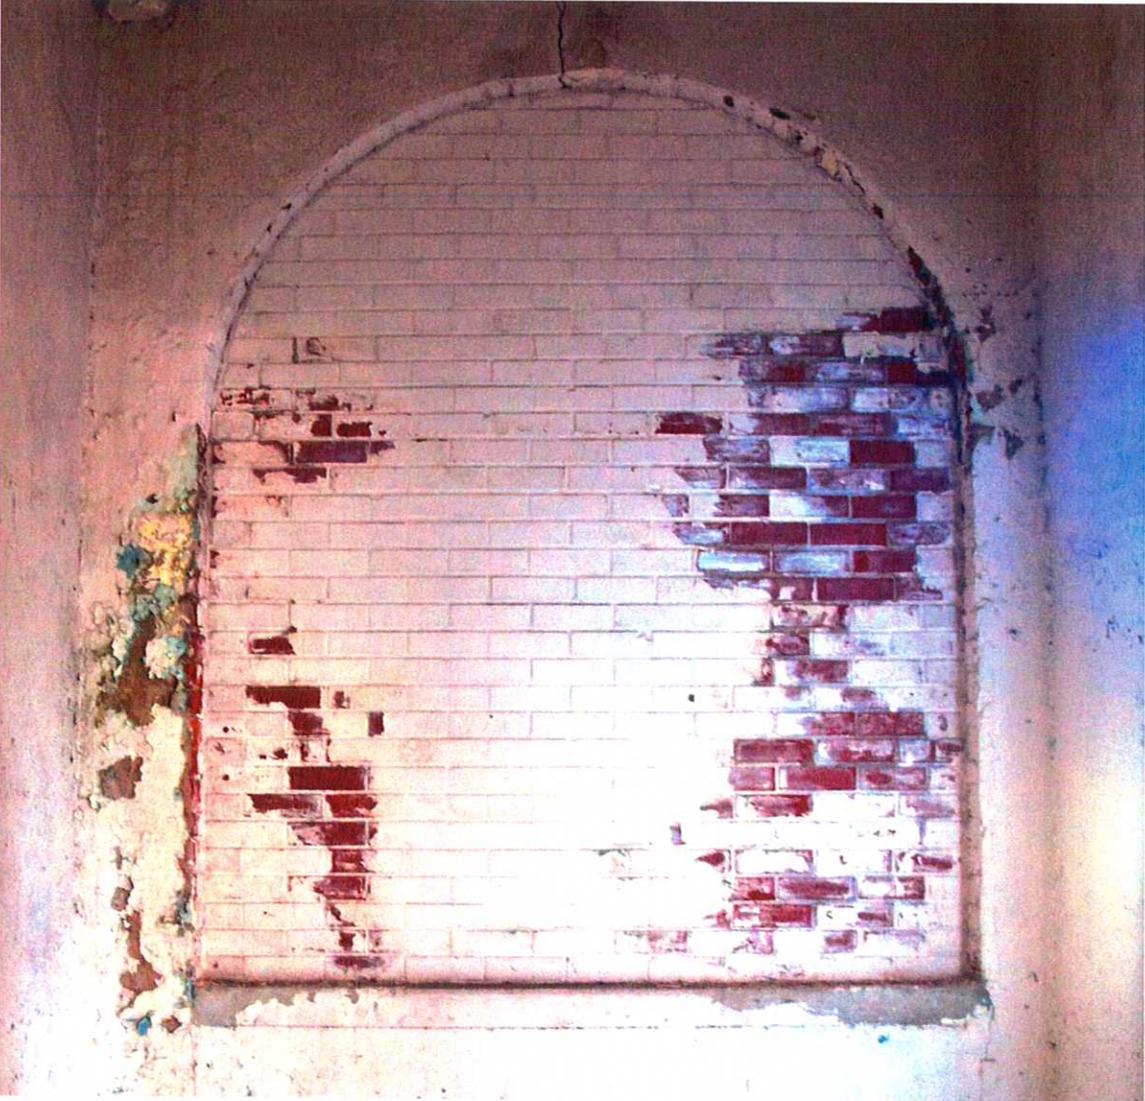
Second Floor Window to Be Reopened

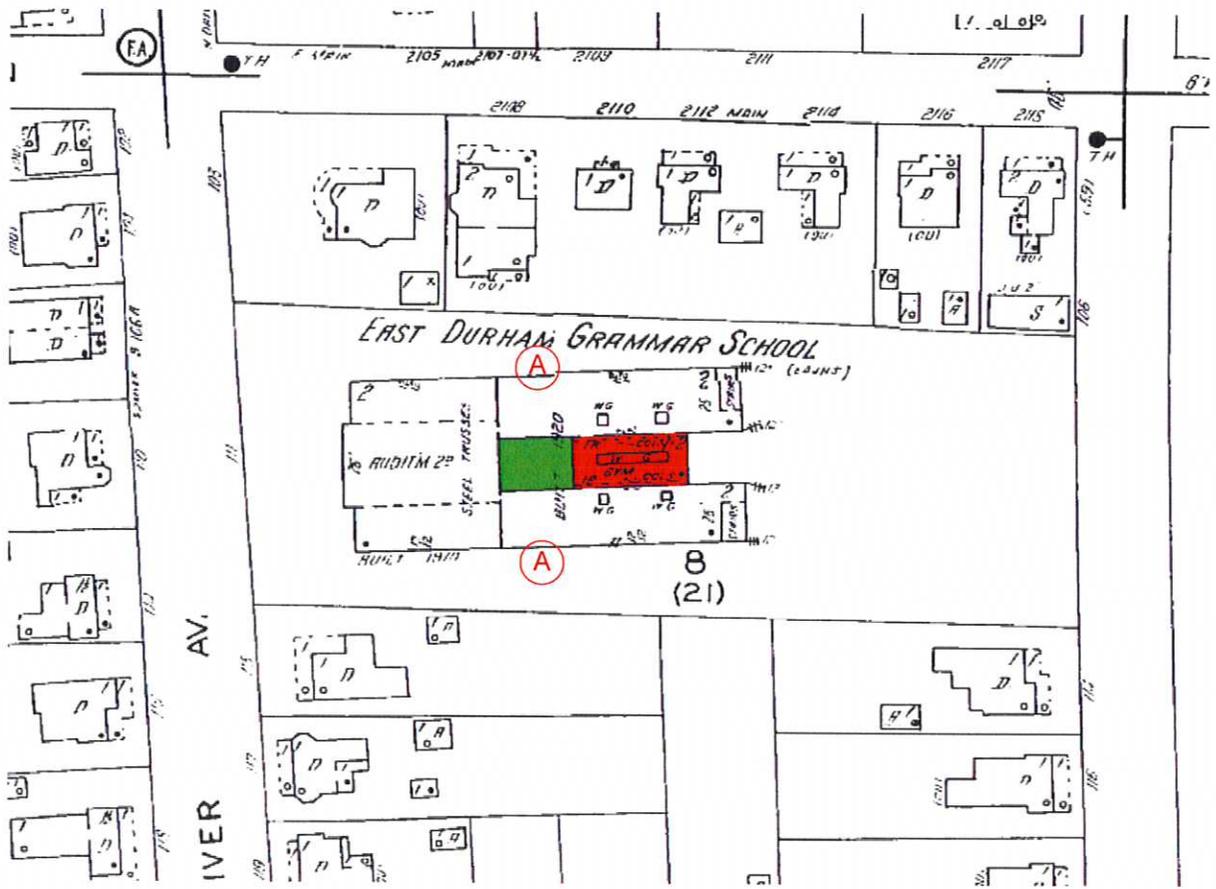
EXCERPT FROM 1937 - 1950 SANBORN MAP

KEY

- GYM: Constructed 1925 - 1937
- COURTYARD: Open air courtyard - created with Gym construction 1925 - 1937
- A CLASSROOM WINGS: Constructed 1920 - 1925

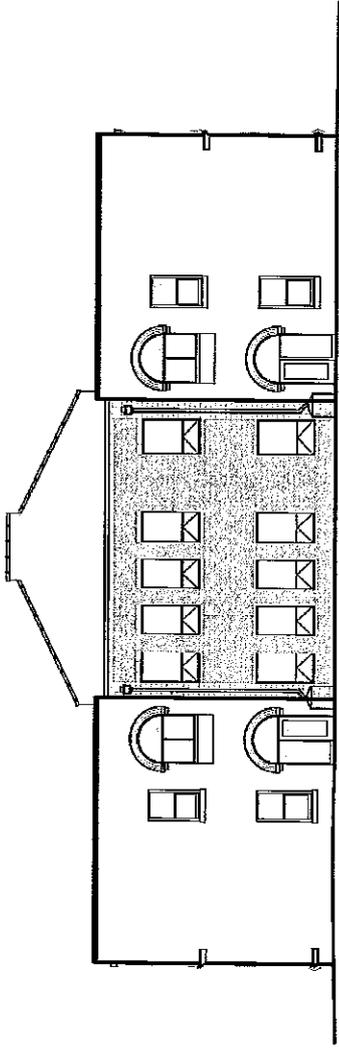
2

EXTERIOR ELEVATION:  
PROPOSED EAST SIDE  
1/16" = 1'-0" @ 36x24

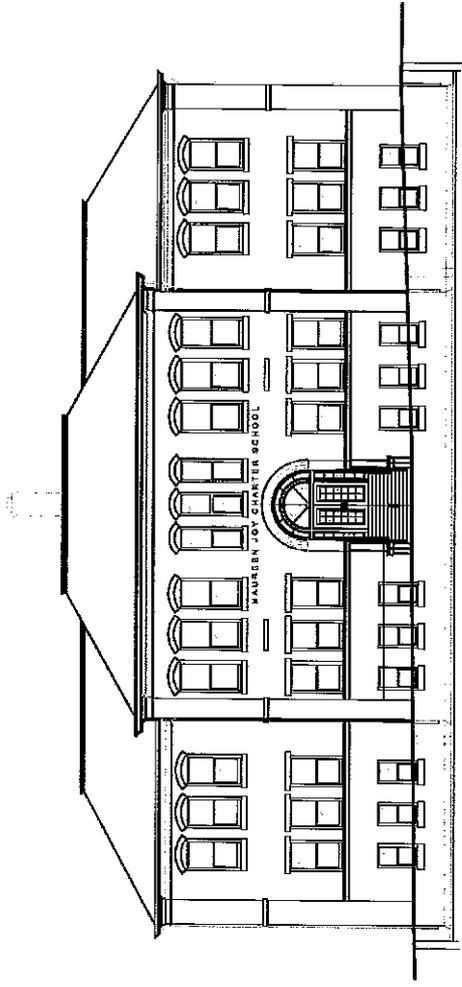
1

EXTERIOR ELEVATION:  
PROPOSED WEST SIDE  
1/16" = 1'-0" @ 36x24
