NC 147 Pedestrian Bridge Sign Issues

The R. Kelly Bryant Downtown Gateway Bridge has been experiencing lighting outages on the arch sign and with one marker light along the bottom of the bridge. This report will provide background on the project with respect to the sign and the other lighting and outline the approach for resolving the issues.

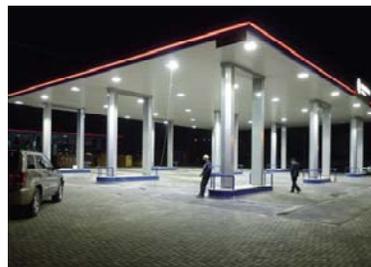
RDU Airport Sculpture

We see similar LED signs every day. LED systems work well in these applications because their life span, when installed per manufacturer’s recommendations, is 50,000 hours or about 12 years (@ 4,000 operating hours per year). The lighting element is similar in concept to LED rope lighting that we all use at Christmas time. However, for commercial applications a more robust version is used that is designed for long, continuous outdoor use. The signs are also easier to maintain because if one 18 inch section fails the rest of the sign should not be affected. With other
