CITY OF DURHAM | DURHAM COUNTY  
NORTH CAROLINA

HISTORIC LANDMARK REPORT

<b>Case</b>	LD1100001	<b>Jurisdiction</b>	City
<b>Project Name</b>	Golden Belt Manufacturing Complex II (Building 1, Additions 10, 11, 12, 13, 14, Building 15, Passageway and Railroad Platform, and Office Addition)		
<b>Request</b>	Historic Landmark Designation		
<b>Site Characteristics</b>	<b>Tier</b>	Downtown	
	<b>Site Acreage</b>	7.108	
	<b>Existing Use</b>	Industrial	
	<b>Date Constructed</b>	1901, 1966, 1990s	
	<b>National Register District</b>	Golden Belt	
	<b>National Register Individually Listed</b>	No	
	<b>Local District</b>	No (pending)	
<b>Applicant</b>	Niemann Capital, LLC	<b>Submittal Date</b>	April 1, 2011
<b>Owner</b>	C C & W Enterprises, LLC		
<b>Location</b>	South of Taylor Street, east of the railroad tracks, and north of Golden Belt Manufacturing Complex		
<b>PIN(s)</b>	0831-10-25-6639		
<b>Recommendations</b>	<b>Staff</b>	Approval	
	<b>Historic Preservation Commission</b>	Approval

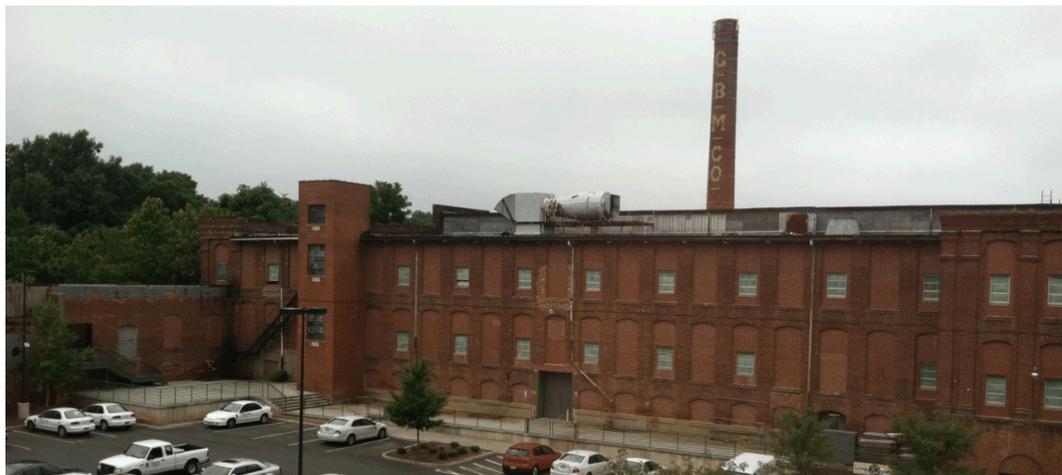
segmental arched windows, towers that extend above the main body of the structures, and detailed ornamental brickwork. The cotton mill is two-and-a-half to three stories with a ceiling height of eleven to thirteen feet. The first floor has a concrete base while the second and third floors have wood floors. Wood columns,

approximately ten feet apart, support the upper floors.

Dating from the first years of the twentieth century, the cotton mill structure is Romanesque Revival in style, with four towers, ornamental brickwork, and rows of closely spaced segmental arched windows. The building's main facade faces the railroad spur to the west. The building is of slow burn construction, with heavy timbered interior supports and thick brick exterior walls.

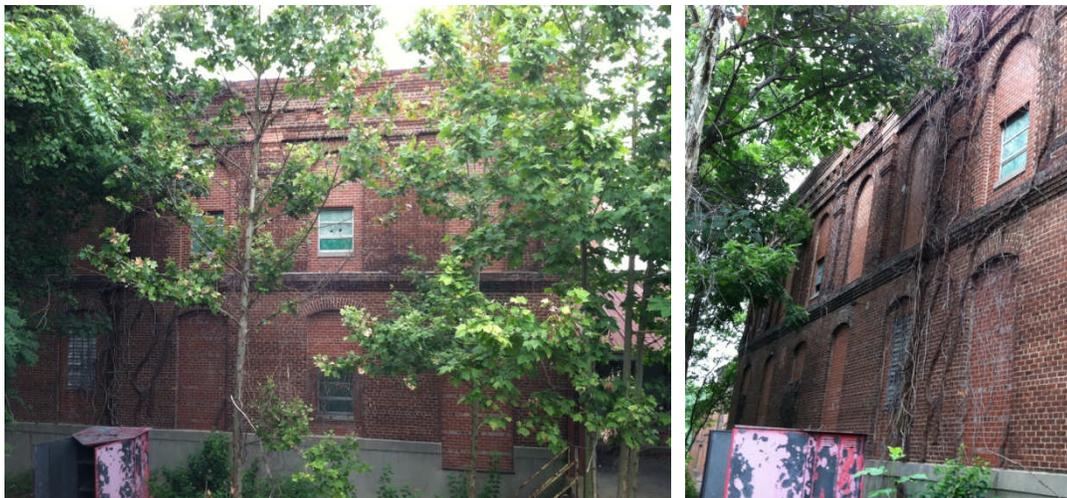
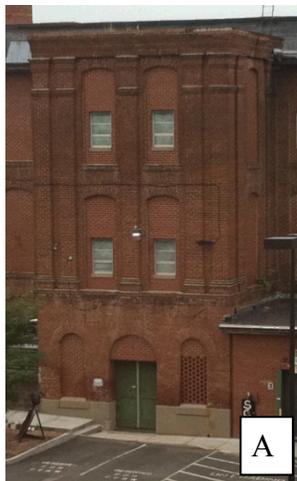
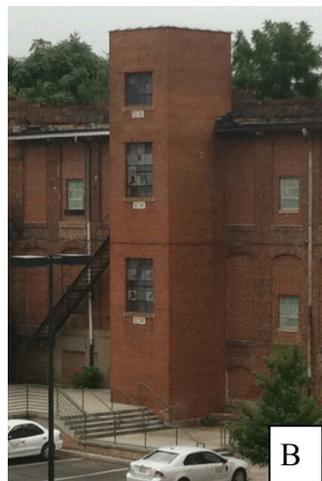
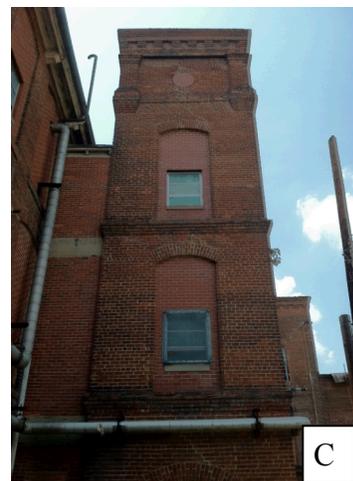
The west elevation, which faces the railroad tracks, has the most significant architectural features including large windows with segmental arches on the first floor and roman arches on the second floor. Doric pilasters flank the windows on the second floor, supporting cornices with corbelled pendants and simple corbelled bands. The building also contains a large arched ground-level opening that was used for railroad deliveries. The first floor interior has wide brick support columns while the second level is an open space with no columns and hardwood floors.

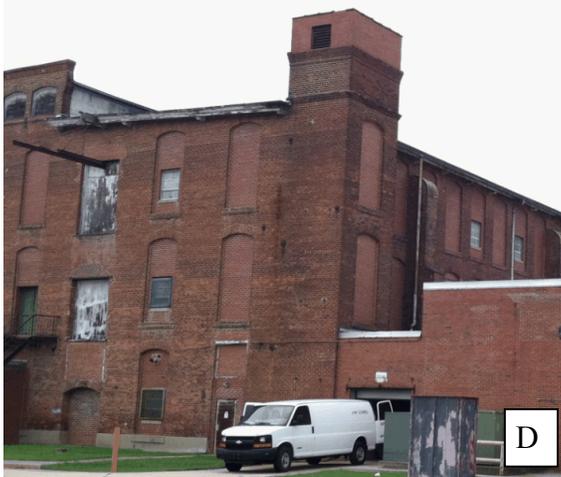
One of the four towers (photo A), located in the center of the south elevation, is just slightly taller than Building 1. It incorporates the same detailing as the main structure, including Doric pilasters, segmental arched windows, which are currently bricked in, and simple brick corbelled cornices. Originally this tower was a full four stories, but the top story has been removed. Two of the four towers

(photos B and D), all on the north elevation of the building, were originally three and a half stories tall with arched windows in the three full stories. The tower in the northeast corner (photo D) has simple corbelled cornices at the roofline of Building 1 and at the top of the original tower. This tower is topped by a later simple brick addition. To contrast, the tower in the middle of the north elevation of Building 1 (photo B) has round

windows in the top half story, all currently bricked in, corbelled cornices at each floor level, and detailed with corbelled pendants and corbelled bands at the top of the towers. The final tower (photo C) is located on the west end of the south elevation of Building 1. This tower was a later addition to accommodate the elevator core and contained no ornamentation. The simple rectilinear lines of this tower are complemented by rectangular, divided-light, metal awning windows.

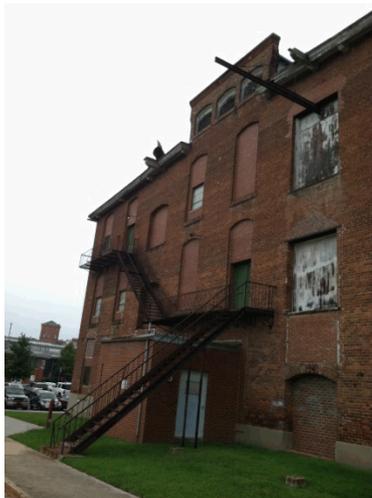
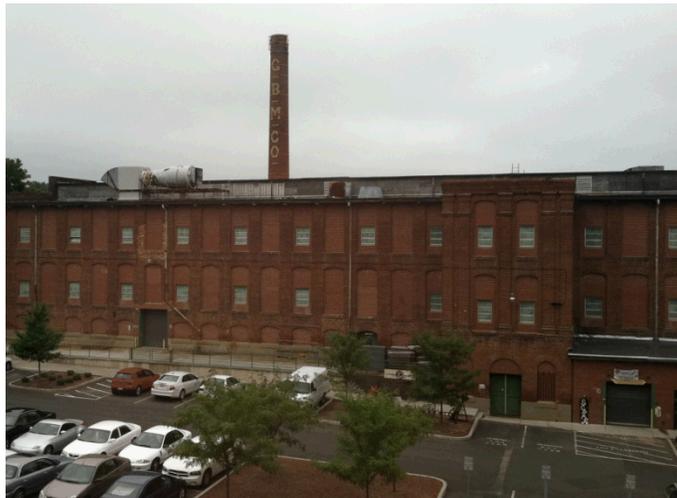
A roof monitor runs the majority of the length of Building 1. This monitor is only visible from ground level at the east end of the building where the brick parapet wall steps up a half story at the center of the building. The parapet wall end of the

monitor has three small arched windows and a simple corbelled cornice. This element has been boarded up and is in disrepair.

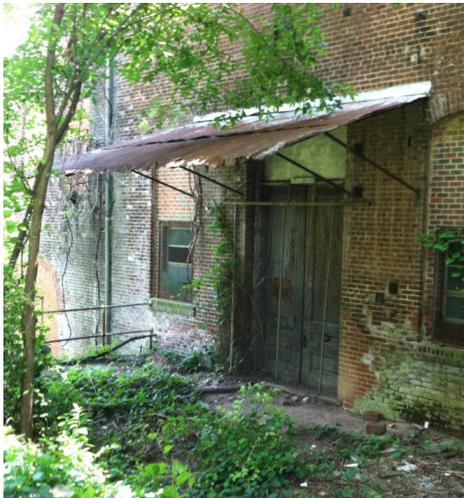
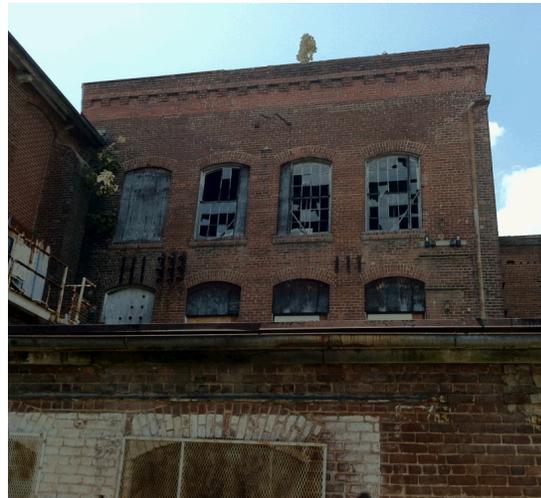
Addition 10 was constructed on the eastern end of the north face of Building 1. It first appears on the 1902 Sanborn map and is also included in the Federal Paper Board architectural plan, which cites its construction as 1901. The east and west elevations have two stories of four segmental arched windows, while the north and south building faces (which abut Addition 11 and Building 1, respectively) have no windows. The cornice has corbelled pendants with simple corbelled bands, detailed similarly to the two towers along the north face of Building 1 and the west end of Building 1. In addition, a red brick was used in a wide band just below the cornice to create contrast with the brown brick facade. Areas of mismatched brick and mortar joints show signs of repair on this building, which indicates previous damage to the building. The interior has a wooden stairwell connecting the first and second floors.

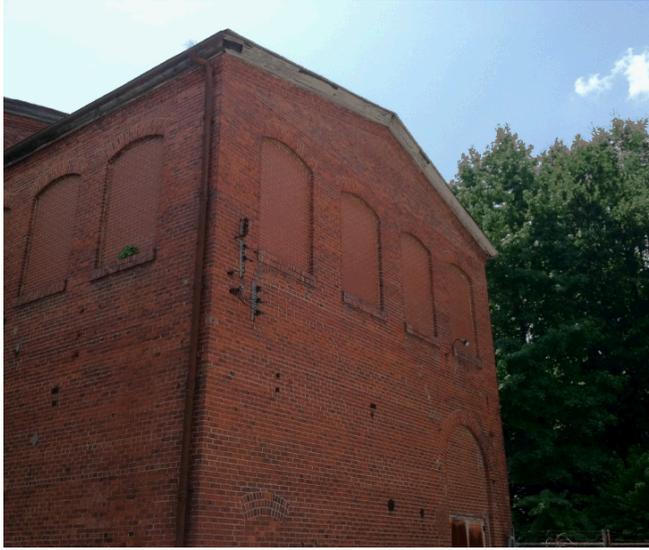
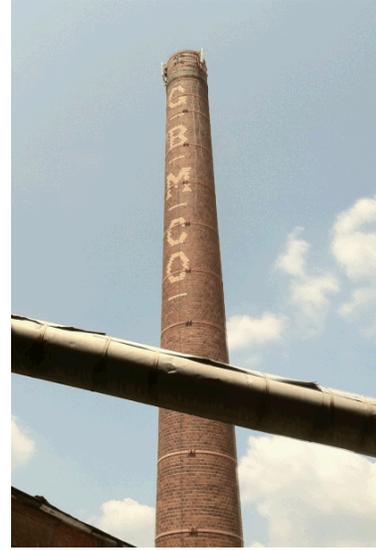
Addition 11 appears on the Sanborn map in 1902, with a small addition noted on the 1907 map. This building housed the boilers for the complex, with three housed in the original building and one added in the addition. The building is two stories tall, with no second story floor. The building was built without a roof, while the addition has a low-pitched, gable roof. Large, segmental arched windows are present throughout the second story, but no window openings exist on the first story. The north side of the building has a large arched opening with a metal door.

The original chimney has “GBMCO” in yellow-gold bricks down the south side. It is connected to Building 11 to enable steam from the boilers to escape. The

brick was recently repointed and the chimney girded when a wireless communication facility was installed.

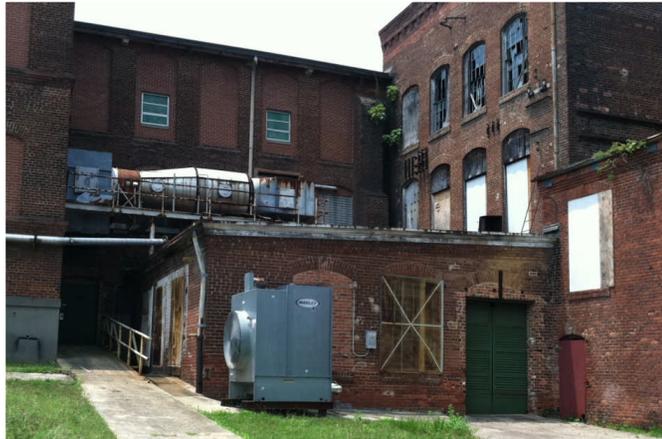
Addition 12 is a small one-story addition, with a flat roof, tucked in the corner north of Building 1 and east of Addition 10. This wing also appears on the 1902 Sanborn Insurance Map. The north elevation has two arched window openings and an arched doorway. The east elevation has three arched window openings.

All of the windows on this building have been bricked in or boarded up.

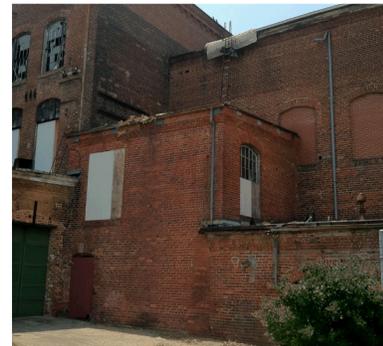
Addition 13 is a small, one and a half story building used to house a chiller. It is situated between Addition 10, 11, and 14, indicating its construction after Buildings 10, 11, and 12 and before Building 14. On the ground level of the east elevation, one doorway exists and contains a metal door. Two segmental arched windows are located on this building, one on the north side and

one on the east side. These are currently partially covered with wood.

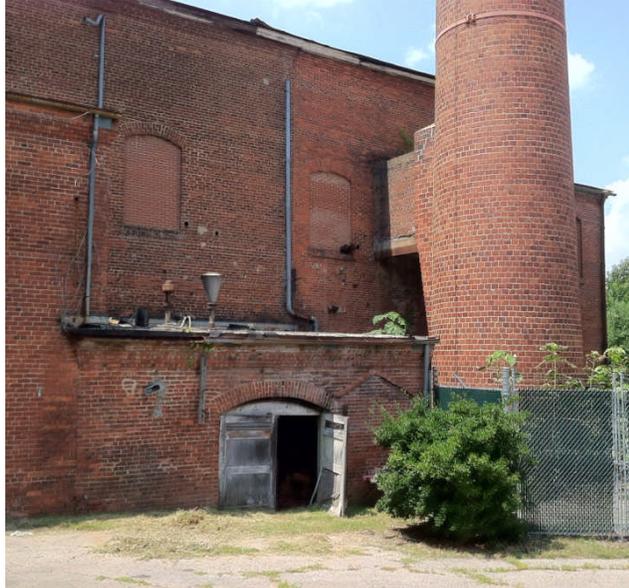
Addition 14 is a small one-story building used for the pump room. It was added when the water tank was installed, which held enough water for the entire sprinkler system. The pump room is attached to Additions 11 and 13, but there is no interior connection. There are only two openings: one arched rectangular window on the north side, currently covered with wood; and an arched ground level doorway with two wood doors. The roof is wood plank and slopes down from Addition 11. The large metal water tank was erected in 1966 and holds 250,000 gallons of water.

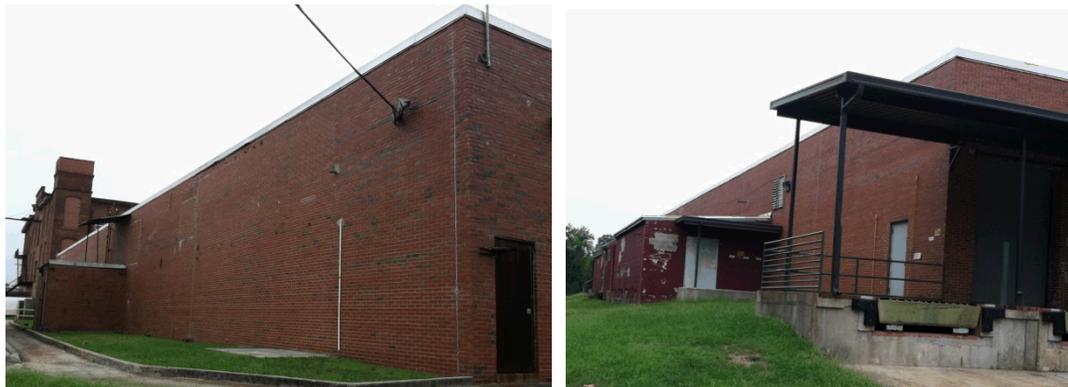
Building 15 is a single-story modern addition that was added onto the north side of the original structure in 1966 to house Golden Belt's expanding plastics production. The building, approximately 43,000 square feet in size, housed the new equipment and allowed the company to diversify its production. The construction of this structure retains the red brick material of the remainder of the complex, but does not include any windows or architectural detailing and portrays a very simple industrial aesthetic. The structure has a concrete roof deck with a built-up roof.

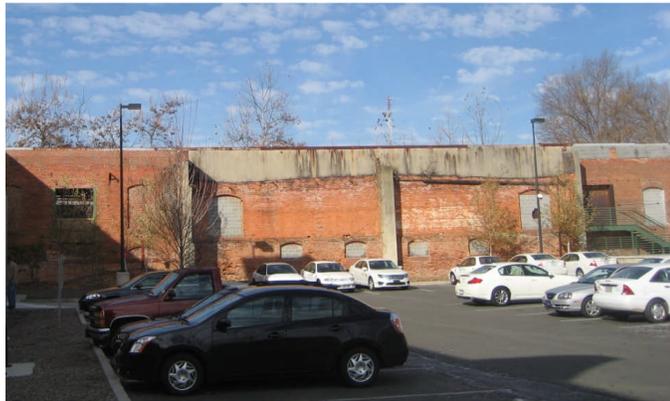
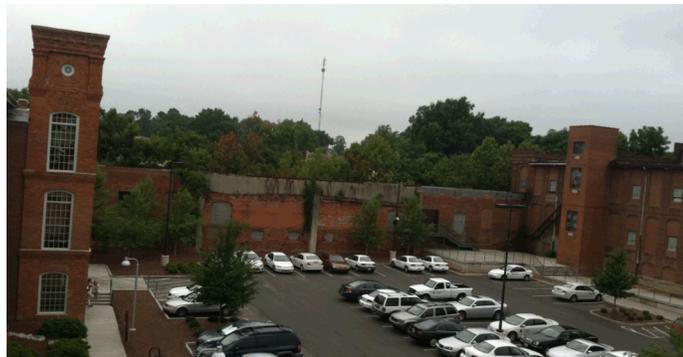
The Passageway and Railroad Platform stretch between Building 1 and Building 2, which is part of the previously designated portion of the Golden Belt Manufacturing Complex. Apparent on the east elevation of the Passageway are several window and door openings, almost all with segmental arches, in an irregular pattern. This structure was originally fully enclosed but has partially deconstructed. The majority of these openings have been closed in with concrete block or brick. The central portion of the brick wall is where the original cotton warehouse, now demolished, was located. Evidence of the removal of that structure remains in the concrete repairs along that portion of the platform. One rectangular doorway retains access to the platform currently and has a large sliding metal door. The Railroad Platform runs parallel to the Passageway and a metal roof covers the platform's concrete pad.

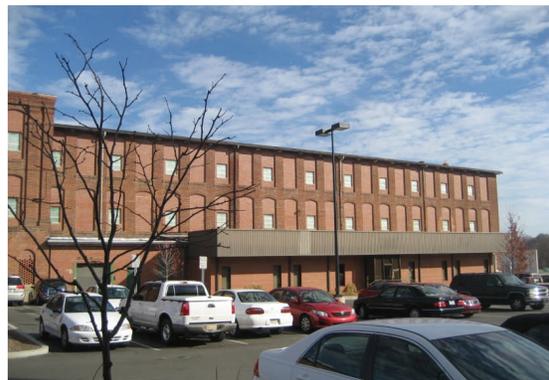
A 3,000 square foot office addition was constructed along the south elevation of Building 1 in the late 1990s. The windows are tall, narrow rectangular modern windows. The flat roof has a thick soffit giving the building a heavy appearance. The interior is new sheetrock, with drop ceilings and is currently office space.

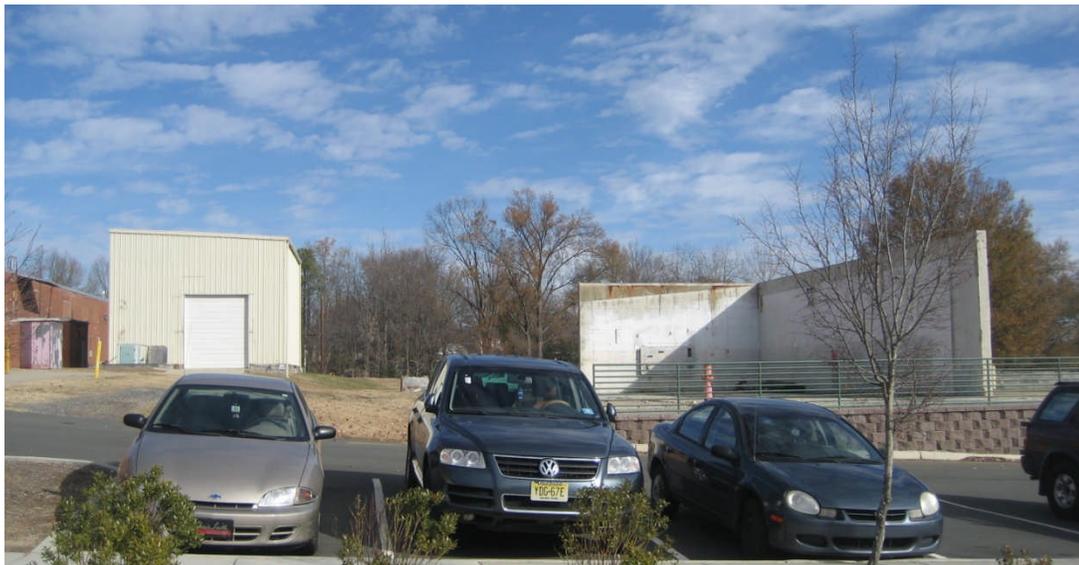
### Concrete Building Remnant

On the eastern portion of the property a concrete building shell was constructed at some point when the dye tanks were stored on that portion of the property.
